**HISTORIC RESOURCES INVENTORY
BUILDING AND STRUCTURES**

1. BUILDING NAME (Common) (Historic)
Parsons, Catherine and Dency, House

3. STREET AND NUMBER (and or location)
48 Main Street

7. STYLE OF BUILDING: Greek Revival DATE OF CONSTRUCTION: ca. 1832

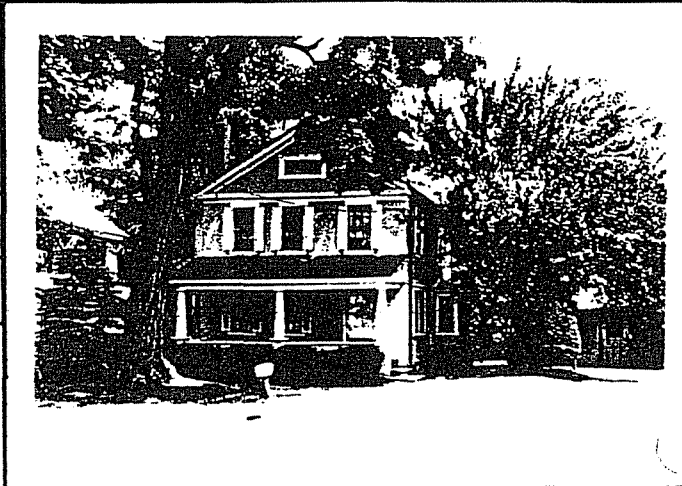
PHOTO	PHOTOGRAPHER	DATE
	P. D. Hall	Summer 1983
COMPILED BY	VIEW	NEGATIVE ON FILE
	west & frontal	III:35
	NAME	DATE
	I. Heublein	8/2/83
ORGANIZATION		
Greater Middletown Preservation Trust		
ADDRESS		
27 Washington Street, Middletown, CT 06457

An unusual element found in the Parsons House is the stuccoed exterior and foundation. Although comparable in size to other homes built during this time, the stuccoing gives the house a sense of weight and massiveness. Its west facade includes the later addition of a full-length shed-roofed porch with south entrance, supported by three large square columns that taper toward the top, and a solid stuccoed balustrade. All windows are six-over-six sash flanked by louvred shutters and topped by a plan cornice. A rectangular multi-pane window is centrally set in the facade gable. There is a 2 story hip-roofed northeast addition as well as two additions on the east or rear of the house.

Catherine and Dency Parsons built their Greek Revival style house about 1832. A stuccoed 2½ story, 3 bay, side-hall-plan building, it rests on a sandstone foundation. Asphalt shingling covers the fully pedimented gable-to-street roof with exterior chimney on the east and the north side.
