**HISTORIC RESOURCES INVENTORY  
BUILDING AND STRUCTURES**

1. BUILDING NAME (Common)		(Historic)	
Durham		Crawford, Elijah J., House	
2. TOWN CITY	VILLAGE	COUNTY	
Durham		Middlesex	
3. STREET AND NUMBER (and or location)			
Maple Avenue, East Side			
4. OWNER(S)			
Mielke, Dorence W.			
		<input type="checkbox"/> Public	<input checked="" type="checkbox"/> Private
5. USE (Present)		(Historic)	
Residence		Residence	
6. ACCESSIBILITY TO PUBLIC:			
EXTERIOR VISIBLE FROM PUBLIC ROAD		INTERIOR ACCESSIBLE	
<input checked="" type="checkbox"/> Yes <input type="checkbox"/> No		<input type="checkbox"/> Yes <input checked="" type="checkbox"/> No	
IF YES EXPLAIN

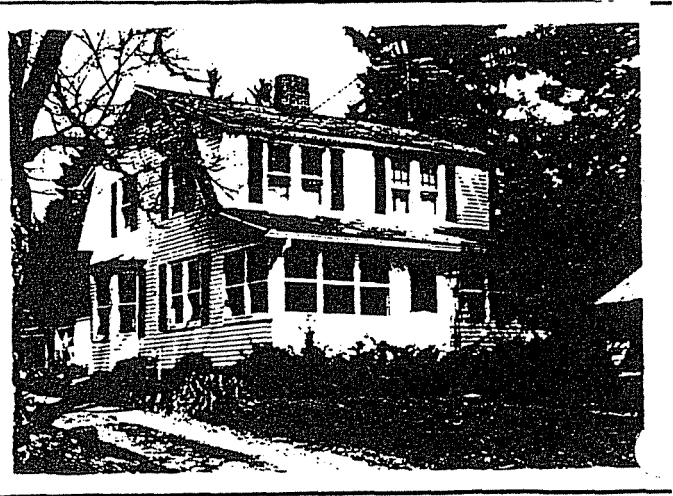
PHOTO

A 1 story addition capped with a shed roof has been added to the rear. A three-sided, hip-roofed bay enhances the rear portion of the south elevation. Windows vary in size: one-over-one sash are featured on the sunporch and six-over-one sash throughout the rest of the house. The center chimney is constructed of brick. Outbuildings include a one-car wooden garage and a concrete block garage.

The Elijah Crawford House is a 1½ story, Colonial Revival style structure built in 1926. Its ridge-to-street asphalt-shingled gambrel roof features a full facade shed dormer with two sets of six-over-one paired windows. The facade exhibits a full frontal, shed-roofed sunporch with central entrance door. Resting on cut stone foundation, the balloon frame is covered in aluminum siding. Elijah J. Crawford (1879-1934), a native of Hudson Falls, New York, and a contractor by trade, erected this building in 1926. He purchased this lot from the First Ecclesiastical Society with the understanding "the grantee will use this lot to erect a house, garage, woodhouse and if desired, a henery" (DLR 36:190). In 1932 the property was sold to the Mielke family, who still retain ownership today. The Elijah J. Crawford House is a fine example of early-twentieth-century domestic architecture erected after WWI when Durham and the rest of the United States were experiencing a period of prosperity, resulting in a building boom. The availability of the automobile allowed many Americans to migrate to the country, suburbia, and small towns like Durham where they built new homes using traditional colonial styles.

PHOTOGRAPHER	DATE
Alex Parades	4/84
VIEW	NEGATIVE ON FILE
Facing east	10:3
NAME	DATE
E. R. Hart	10/83
ORGANIZATION	
Greater Middletown Preservation Trust	
ADDRESS	
27 Washington St., Middletown, Conn. 06457
