HISTORIC RESOURCES INVENTORY
BUILDING AND STRUCTURES
 HIST-6 NEW 5 77

1. BUILDING NAME (Common) (Historic)
 Coe, Merrick R., House

2. TOWN CITY VILLAGE COUNTY
 Durham Middlesex

3. STREET AND NUMBER (and or location)
 New Haven Road, east side

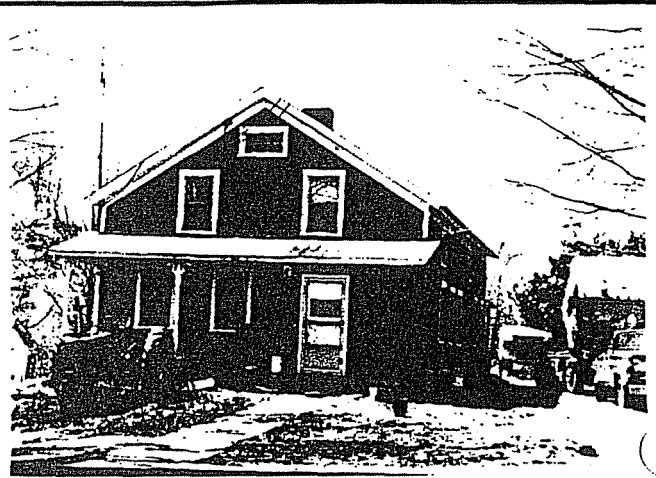
PHOTOGRAPHER	DATE
Alex Parades	5/84
VIEW	NEGATIVE ON FILE
E	13:21
NAME	DATE
E. R. Hart	3/84
ORGANIZATION	
Greater Middletown Preservation Trust	
ADDRESS	
27 Washington St., Middletown, Conn. 06457

<input type="checkbox"/> Excellent	<input type="checkbox"/> Good	<input checked="" type="checkbox"/> Fair	<input type="checkbox"/> Deteriorated	<input type="checkbox"/> Excellent	<input type="checkbox"/> Good	<input checked="" type="checkbox"/> Fair	<input type="checkbox"/> Deteriorated
------------------------------------	-------------------------------	--	---------------------------------------	------------------------------------	-------------------------------	--	---------------------------------------

<input checked="" type="checkbox"/> On original site	<input type="checkbox"/> Moved	<input checked="" type="checkbox"/> Yes	<input type="checkbox"/> No	E11 and porch added to facade
--	--------------------------------	---	-----------------------------	-------------------------------

The two-over-three-bay facade displays a single-story, open porch and a modern enclosed entry ell. Lath-turned columns with scroll-sawn brackets support the porch's shed roof. The gable end exhibits a ten-pane rectangular window. Six-over-six sash are featured throughout and the second floor of the north and south elevations features smaller six-over-six windows. A large barn and numerous out-buildings are found on the lot.

This 1½ story, gable-to-street, nineteenth-century vernacular style dwelling was built in 1827. Anchoring its clapboarded, post-and-beam frame is a foundation of sandstone. The asphalt-shingled roof features a diminutive brick chimney.
