HISTORIC RESOURCES INVENTORY
BUILDING AND STRUCTURES
 HIST-6 NEW 5 77

IDENTIFICATION	1. BUILDING NAME (Common) (Historic)	
	Bailey, James E. House	
	2. TOWN CITY	VILLAGE COUNTY
	Durham	Middlesex
	3. STREET AND NUMBER (and or location)	
Parmelee Hill Road, south side at intersection of Pent Road		
4. OWNER(S)		
Town of Durham/ Caltabiano, A. <input checked="" type="checkbox"/> Public <input type="checkbox"/> Private		
5. USE (Present) (Historic)		
Residence Residence		
6. ACCESSIBILITY TO PUBLIC: <input checked="" type="checkbox"/> Yes <input type="checkbox"/> No		
EXTERIOR VISIBLE FROM PUBLIC ROAD <input type="checkbox"/> Yes <input type="checkbox"/> No		
INTERIOR ACCESSIBLE <input type="checkbox"/> Yes <input checked="" type="checkbox"/> No		
IF YES, EXPLAIN

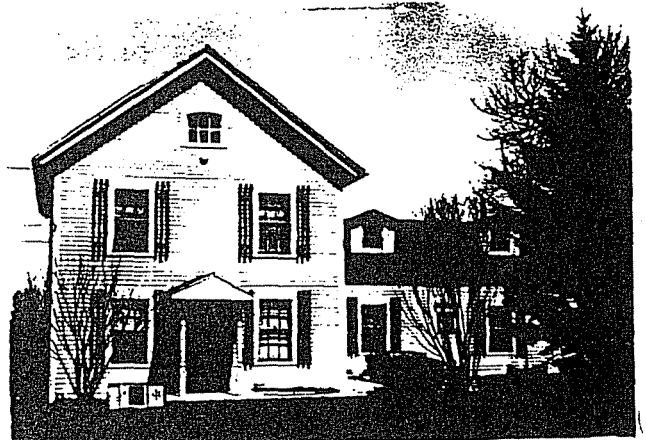
PHOTOGRAPHER	DATE
Alex Parades	5/84
VIEW	NEGATIVE ON FILE
Facing Northwest	13:18
NAME	DATE
E. R. Hart	1/84
ORGANIZATION	
Greater Middletown Preservation Trust	
ADDRESS	
27 Washington St., Middletown, Conn. 06457

Surmounted by a four-paned overlight, the four-panelled central door is protected by a simple pedimented entrance portico. It is supported by four turned columns with square bases and capitals. The 1½ story, 4-bay ell located on the western elevation features a ridge-to-street gable roof with two small dormers displaying six-over-one sash. Six-over-six sash are found throughout the rest of the house. A six-paned relieving arched window is exhibited in the facade gable end. A tall brick chimney is found on the western ell and a modern concrete-block chimney is featured on the north elevation of the main block. Outbuildings include a large 2 story barn with silo, a smaller single story concrete block barn, and other farm-related structures.

Located at the intersection of Parmelee Hill and Pent Roads, this 2½ story, 3 - bay, late nineteenth-century Domestic-style dwelling was built by James E. Bailey in 1872. Supported by a brownstone foundation, the clapboarded balloon frame is capped with an asphalt-shingled gable-to-street roof.
