HISTORIC RESOURCES INVENTORY
BUILDING AND STRUCTURES
 HIST-6 NEW 5 77

IDENTIFICATION	1. BUILDING NAME (Common) (Historic)	
	Nettleton, Eliphaz, House	
	2. TOWN/CITY	VILLAGE COUNTY
	Durham	Middlesex
	3. STREET AND NUMBER (and or location)	
Pisgah Road, North side		
4. OWNER(S)		
Bernsten, Fred & Linda <input type="checkbox"/> Public <input checked="" type="checkbox"/> Private		
5. USE (Present) (Historic)		
Residence Residence		
6. ACCESSIBILITY TO PUBLIC: <input checked="" type="checkbox"/> Yes <input type="checkbox"/> No		
EXTERIOR VISIBLE FROM PUBLIC ROAD <input checked="" type="checkbox"/> Yes <input type="checkbox"/> No		
INTERIOR ACCESSIBLE <input type="checkbox"/> Yes <input checked="" type="checkbox"/> No		
IF YES, EXPLAIN

DESCRIPTION	7. STYLE OF BUILDING		DATE OF CONSTRUCTION	
	Center-chimney Cape		1793	
	8. MATERIAL(S) (Indicate use or location when appropriate)			
	<input checked="" type="checkbox"/> Clapboard	<input type="checkbox"/> Asbestos Siding	<input type="checkbox"/> Brick	<input type="checkbox"/> Other (Specify) _____
	<input type="checkbox"/> Wood Shingle	<input type="checkbox"/> Asphalt Siding	<input type="checkbox"/> Fieldstone	
	<input type="checkbox"/> Boa

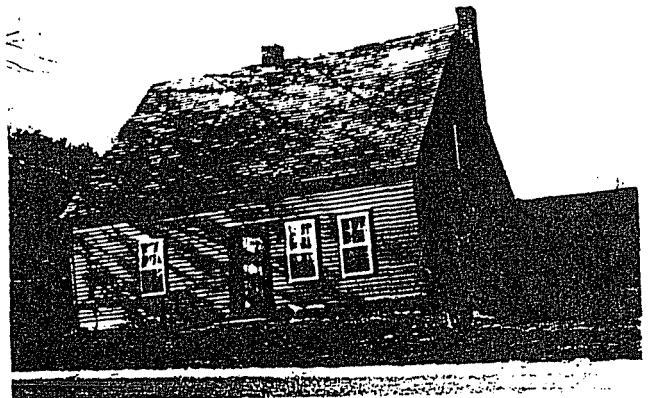
PHOTO

The three bay facade features a simple board and batten central door flanked by two flush-set six-over-six windows. The large center chimney was replaced in the mid-nineteenth-century. The eastern gable features two six-over-six sash placed on either side of a modern exterior brick chimney. Surrounding the upper floor windows are two of the three small, four-paned windows found commonly on Cape style buildings. The third small window presumably is hidden by the chimney. Containing a workshop and screened porch, a single story shed-roofed addition has been added to the north and east elevations. Outbuildings on the property include a small wooden barn and shed.

Facing south at the intersection of Pisgah and Dead Hill Roads, this 1½ story, Colonial Cape-style dwelling was erected in 1793. Topped with a ridge-to-street, wood-shingled roof, the clapboarded, post-and-beam frame rests on a concrete-covered fieldstone foundation

PHOTOGRAPHER	DATE
Alex Parades	4/84
VIEW	NEGATIVE ON FILE
N	10:28
NAME	DATE
E.R. Hart	3/84
ORGANIZATION	
Greater Middletown Preservation Trust	
ADDRESS
