**HISTORIC RESOURCES INVENTORY  
BUILDING AND STRUCTURES**

IDENTIFICATION	1. BUILDING NAME (Common) <span style="float: right;">(Historic)</span> Hart, Samuel, House	
	2. TOWN CITY Durham	VILLAGE COUNTY Middlesex
	3. STREET AND NUMBER (and or location) Stage Coach Road, north side	
	4. OWNER(S) Plate, Frank & Julia <span style="float: right;"><input type="checkbox"/> Public <input checked="" type="checkbox"/> Private</span>	
	5. USE (Present) <span style="float: right;">(Historic)</span> Residence <span style="float: right;">Residence</span>

SAMUEL HART HOUSE, Durham

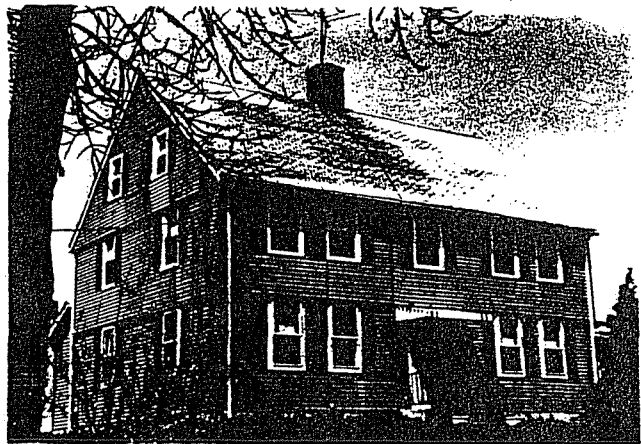
PHOTO

Like other eighteenth-century farmhouses built in outlying parts of Durham, this house displays little architectural detailing. The original center chimney has been replaced by a smaller brick chimney stack. Modern one-over-one sash replace the original windows. The facade entry is protected by a modern aluminum doorhood. Small additions extend from the east and north elevations.

Facing southeast onto Stage Coach Road, the Samuel Hart House is a late example of the 2½ story, central-chimney, colonial-period house form which displays double-hewn overhangs. Built ca. 1780, the aluminum-sided, post-and-beam frame is supported by a modern cement foundation. The steeply-pitched, ridge-to-street gable roof is asphalt-shingled.
