**HISTORIC RESOURCES INVENTORY
BUILDING AND STRUCTURES**

| | Meigs, Elias, House | |
| | Durham | |
| | Town House Road, west side, 1 m. south of Maple Avenue | |

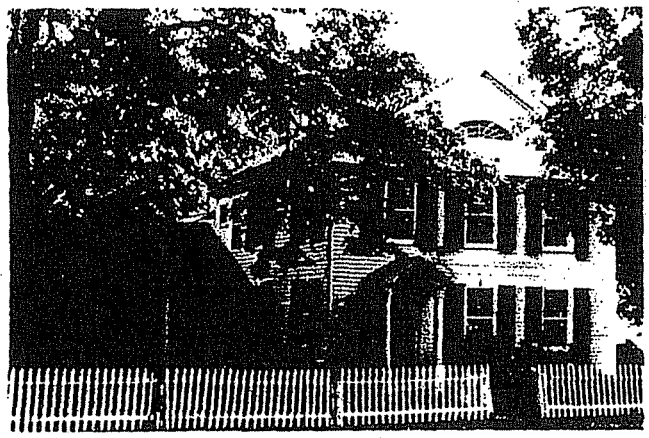
VIEW: East elevation NEGATIVE ON FILE: 6:1

This 2½ story Federal-style residence in many ways resembles the Charles Camp House, which stands just to the south of it. Both are side-hall plan structures with gable ends facing the street. The Meigs House, however, possesses that hallmark of the Federal style, a demi-lunette fanlight in its gable peak. It also possesses an elegant leaded glass fanlight over its front entry, which is protected by a cove-ceilinged gable-roofed portico supported by Doric columns. A shed-roofed 10 x 16 addition, probably contemporary with the main block, stands to the rear of the structure. In 1980 a single-story gable-roofed addition was made to the south side of the main block.
