STATE OF CONNECTICUT
CONNECTICUT HISTORICAL COMMISSION
59 SOUTH PROSPECT STREET, HARTFORD, CONNECTICUT 06106
(203) 566-3005

1. BUILDING NAME (Common) <i>(Historic)</i>		Paul Haake House		Daniels, H. D., House	
2. TOWN/CITY		VILLAGE		COUNTY	
Durham				Middlesex	
3. STREET AND NUMBER (and or location)					
Haddam Quarter Road, north side, .1 m east of Foothills Road

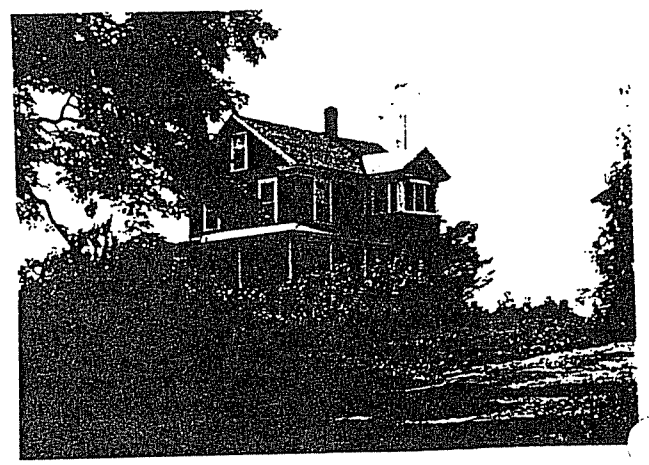
The Haake House is a simple farmhouse in the late-nineteenth-century Domestic style, representative of the houses built in Durham between 1890 and 1920. Built with a balloon frame and sheathed with painted wooden shingles, it is devoid of ornament, save for modest cornice returns at its gable ends. It is a 2½ story, rectangular building with a small 2 story dormer projecting from the rear of its east side. The first story facade and east side are obscured by a shed-roofed porch original to the house. The windows are two-over-two throughout. The front door, original to the house, consists of two wooden panels below with a plate glass window in its top half.

PHOTOGRAPHER	DATE
P. D. Hall	6/5/83
VIEW	NEGATIVE ON FILE
South and east / sides	VIII:23
NAME	DATE
P. D. Hall	2/1/84
ORGANIZATION	
Greater Middletown Preservation Trust	
ADDRESS	
27 Washington Street, Middletown, CT 06457
