**HISTORIC RESOURCES INVENTORY
BUILDING AND STRUCTURES**

| The Stengel House | Baldwin, David, House | |
| Northwest corner of Foothills Road and Haddam Quarter Road | | |

Baldwin, David, House, Foothills/Haddam Quarter Road, Durham

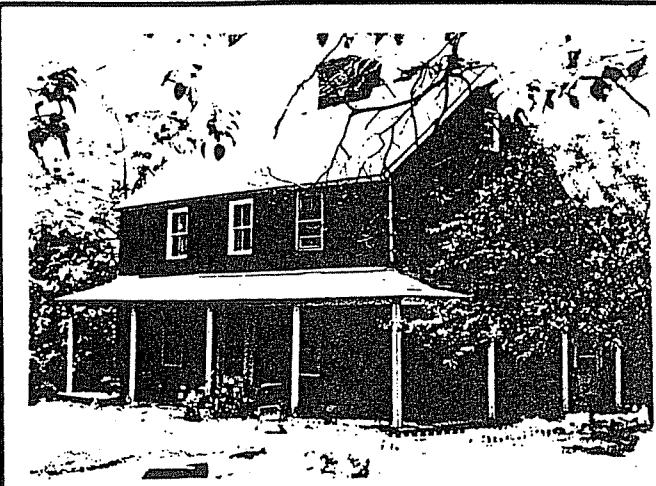
| south & east sides | 8:22 |

The David Baldwin House is a 2½ story, central chimney Colonial saltbox. Although it still possesses its original brick central chimney, it no longer contains operating fireplaces. Like most of Durham's earliest houses, the Baldwin house has a 3 bay facade. Its centrally placed entryway contains what appears to be an original wooden 7 seven-panel front door with original hardware, framed with plain elements. The windows in the first and second stories of the facade contain two-over-two sash, replacements dating from the first half of the twentieth century. The facade and east side of the first story of the main block are obscured by a shed-roofed porch supported by four-over-four posts. This porch is of late-nineteenth-century origin. The conformation of the gable ends of the main block indicates that the saltbox lean-to is integral to the structure. The fenestration in the gable ends consists of three two-over-two sash, (SEE CONT. SHEET)

Two additions have been attached to the northeast corner of the main block, both dating from the late-nineteenth or early-twentieth centuries. The first is a 15' x 22', 1½ story ell, which is shingled like the main block. The second is a windowless shed attached to the north end of the ell.
