**HISTORIC RESOURCES INVENTORY
BUILDING AND STRUCTURES**

IDENTIFICATION	1. BUILDING NAME (Common) (Historic) Edwards' Candle House and Collies Farm Southmayd, Elisha, House	
	2. TOWN CITY Durham	VILLAGE Middlesex

3. STREET AND NUMBER (and or location) Haddam Quarter Road, north side, .7 miles east of Brick Lane	
	4. OWNER(S) Robert & Patricia Edwards <input type="checkbox"/> Public <input checked="" type="checkbox"/> Private

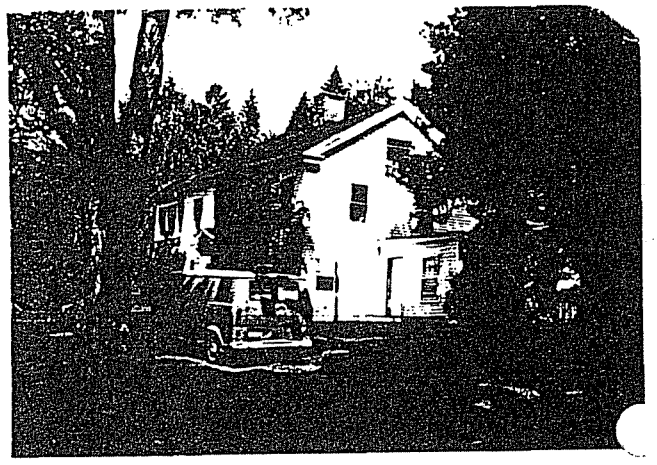
PHOTO	PHOTOGRAPHER	DATE
	P. D. Hall	6/5/83
VIEW	VIEW	NEGATIVE ON FILE
	Southeast side	1:6
COMPILED BY	NAME	DATE
	P. D. Hall	2/1/84
	ORGANIZATION	
	Greater Middletown Preservation Trust	
ADDRESS	27 Washington Street, Middletown, CT 06457

The Elisha Southmayd House is one of four residences on the Haddam Quarter Road associated with the Southmayd Family. The structure consists of a central chimney, Federal style main block, with additions to the west, east, and north sides. The main block, which dates from the mid-1830s, is 2½ stories high with a 5 bay facade. It has a centrally located entryway sheltered by an entry porch ornamented with dentillations and supported by two recessed panel columns. This porch dates from the late-nineteenth century and obviously replaced an earlier Federal style entry with a fanlight and pilasters. The replacement door is topped by a 3 pane transom of twentieth-century origins. The windows on the first and second stories of the facade are six-over-six. Although the main block contains no dentil course under the eaves, the gable ends are ornamented with (SEE CONT. SHEET)
