HISTORIC RESOURCES INVENTORY
BUILDING AND STRUCTURES
 HIST-6 NEW, 5 77

IDENTIFICATION	1. BUILDING NAME (Common) (Historic)	
	Hartnett, Jr., Edmund, House	
	2. TOWN CITY Durham	VILLAGE Middlesex
	3. STREET AND NUMBER (and or location) Madison Road, east side

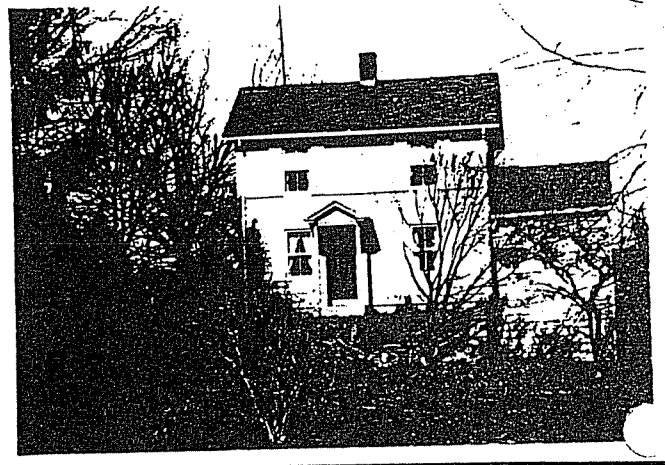
VIEW NE NEGATIVE ON FILE 10:26

The two-over-three-bay facade features an offset central door entry shielded by a pedimented portico supported by square posts. Another notable exterior feature are the broad overhanging eaves which are characteristically found on similar period structures in the area. Two-over-two sash are exhibited throughout and a single-story ell projects from the southern elevation.

Edmund Hartnett Jr. erected this plain, 2½ story, late-nineteenth-century Domestic-style dwelling in 1882. Resting on a sandstone foundation, the balloon frame is sided with aluminum clapboards on the first story and aluminum board-and-batten on the second level. The asphalt-shingled gable roof is oriented ridge-to-street.
