**HISTORIC RESOURCES INVENTORY
BUILDING AND STRUCTURES**

1. BUILDING NAME (Common) (Historic)
Hull, Leonard, House

2. TOWN CITY VILLAGE COUNTY
Durham Middlesex

3. STREET AND NUMBER (and or location)
E. Madison Road

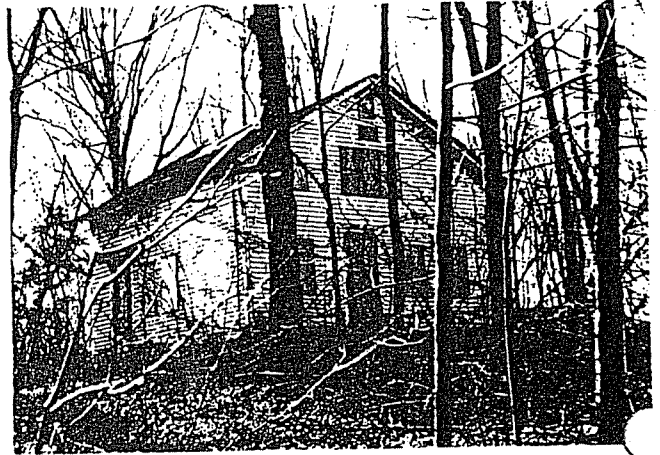
PHOTOGRAPHER Alex Parades	DATE 5/84
VIEW northwest	NEGATIVE ON FILE 10:17

Peculiarly situated upon a small hill amid large rock formations, the three-bay facade appears to face south away from the road. Throughout the house the fenestration has an unbalanced arrangement. The facade exhibits a side entrance flanked by two (boarded-up) windows. The second story features two asymmetrically placed, smaller windows of different sizes. The east elevation features overhanging eaves and an interesting placement of windows in the gable end; a center tripartite sash flanked by two smaller square windows and topped by two similar square windows. A single story, shed-roofed ell has been added to the western elevation. The only notable architectural detailing is the bracketed entrance hood which protects the facade doorway.

This unusual 1½ story, early nineteenth-century, Domestic-style building was erected in 1837 by Leonard Hull. Sided in clapboards, the post-and-beam framing system rests on a brownstone foundation. The house is capped by an asphalt-shingled gable roof.
