**HISTORIC RESOURCES INVENTORY
BUILDING AND STRUCTURES**

IDENTIFICATION	1. BUILDING NAME (Common) (Historic) Curtis-Coe House	
	2. TOWN CITY Durham	VILLAGE COUNTY Middlesex
	3. STREET AND NUMBER (and or location) Maiden Lane, north side

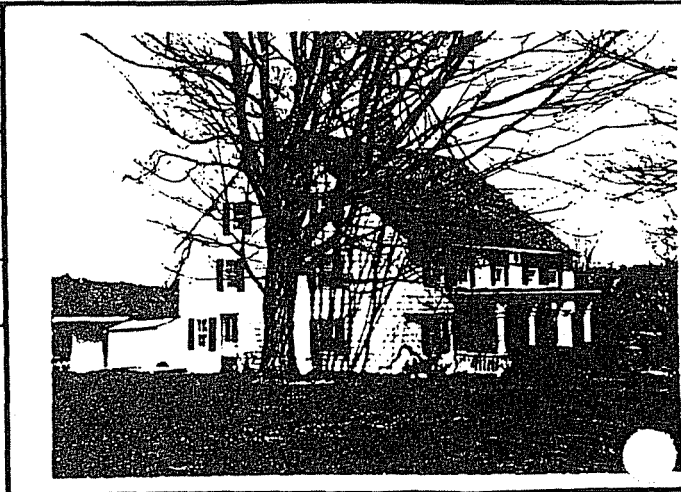
PHOTO	PHOTOGRAPHER Alex Parades	DATE 5/84
	VIEW Northeast	NEGATIVE ON FILE 11:30A
COMPILED BY	NAME E. R. Hart	DATE 5/84
	ORGANIZATION Greater Middletown Preservation Trust	
	ADDRESS 27 Washington Street, Middletown, CT 06457

The five-bay facade, which features a large frontal overhang, is highlighted by a decorative, Victorian-period veranda. Identical to the veranda on the Andrew Hull Homestead (114 Main Street), it is most likely that Mr. Hull, a builder, erected this porch also. Supported by turned posts and decoratively sawn brackets, the porch features an elaborately sawn balustrade. The second floor exhibits original eight-over-twelve sash and the first floor displays six-over-six windows. Two small additions extend from the rear. A number of small farm buildings remain on the grounds.

Built about 1745, this 2½ story, center-chimney, Colonial-period house rests on a sandstone foundation. The wood-shingled post-and-beam timbers are topped with a ridge-to-street, asphalt-shingled gable roof.
