HISTORIC RESOURCES INVENTORY
BUILDING AND STRUCTURES
 HIST-6 NEW 5 77

| Carolyn Adams House | The Parmalee, James, House |
| 153 Main Street | |

THE JAMES PARMALEE HOUSE, 153 Main Street, Durham

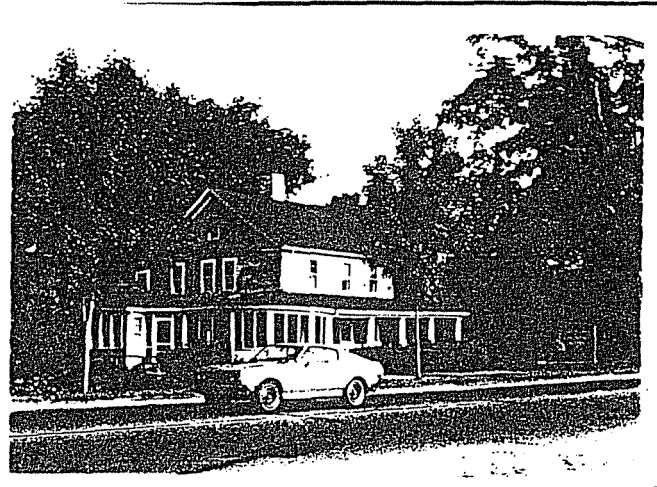
| | S & E elevation | III: 25 |

This 2½ story Federal central chimney house stands at the north end of Durham's Main Street, just outside the Historic District. As built, it was a simple, 3 bay colonial house with Federal-style features: quarter-lune fanlights in the gable ends, cornice returns, full length corner pilasters, and an entry flanked by fluted pilasters with caps and bases and surmounted by a pediment. The house has undergone extensive alterations, most of them dating from the nineteenth century. These include the addition of a hip-roofed, open porch on the south, east and north sides, a sun porch and a screened porch to the south and a 2 story, gable-roofed, addition to the rear. The original clapboarding, which is still intact, has been covered with blue-painted stucco. The original central chimney has been reduced in size--though it still serves two fireplaces. The original fenestration has been partially replaced: the lower sections of what were once 6x6s now contain two-pane operating units. When the porch was added in the late nineteenth century, the pediment over the doorway was removed. According to Fowler, this house stands on the site of an earlier eighteenth-century structure built by Hezekiah Baldwin, who acquired the property from his father, Noah Baldwin. Noah Baldwin had, in turn, received it from his father with a "dwelling, barn, and weaver's shop" in 1765. Fowler states that the old house was razed and that the present structure was built by James Parmalee, Jr. (1763-18), one of Durham's leading shoe makers. Parmalee and his father, Phineas, formed the shoemaking firm of Phineas Parmalee & Company, which carried on its business on the site. They were prosperous initially, judging from this substantial and rather elegant house. But in the late 1820s they, like many shoemakers, found themselves in financial
