1. BUILDING NAME (Common) <i>(Historic)</i>	
None	Parmalee, William A. House
2. TOWN CITY	VILLAGE COUNTY
Durham	Middlesex
3. STREET AND NUMBER (and or location)	
138 Main Street	
4. OWNER(S)	
Eick, Albert and Shirley <input type="checkbox"/> Public <input checked="" type="checkbox"/> Private	
5. USE (Present) <i>(Historic)</i>	
Residence	
6. ACCESSIBILITY TO PUBLIC:	EXTERIOR VISIBLE FROM PUBLIC ROAD INTERIOR ACCESSIBLE IF YES, EXPLAIN
<input checked="" type="checkbox"/> Yes <input type="checkbox"/> No	<input checked="" type="checkbox"/> Yes <input type="checkbox"/> No with permission

HISTORIC RESOURCES INVENTORY FORM  
For Buildings and Structures

Parmelee, William A. House  
138 Main Street  
Durham:

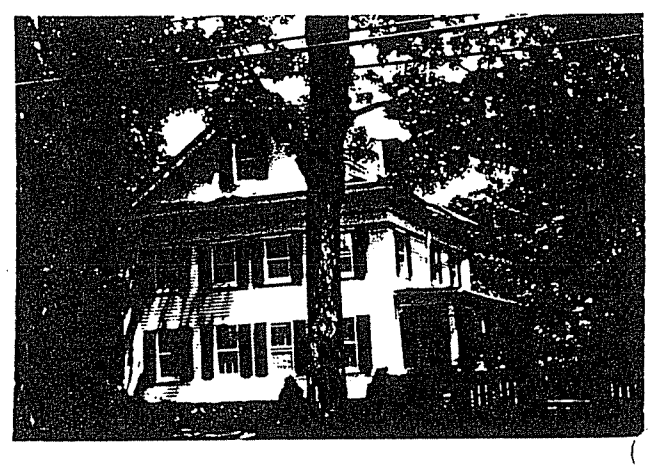
PHOTOGRAPHER	DATE
Peter D. Hall	6/5/83
VIEW	NEGATIVE ON FILE
S&W elevations	III: 4
NAME	DATE
P. D. Hall	8/10/83
ORGANIZATION	
Greater Middletown Preservation Trust	
ADDRESS	
27 Washington Street, Middletown, Conn. 06457
