1. BUILDING NAME (Common) <i>(Historic)</i>		Crowell, Elmer W., House	
2. TOWN CITY	VILLAGE	COUNTY	
Durham		Middlesex	
3. STREET AND NUMBER (and or location)			
137 Main Street			
4. OWNER(S)			
Beaty, Jeffery G. & Kathleen M.		<input type="checkbox"/> Public	<input checked="" type="checkbox"/> Private
5. USE (Present)		<i>(Historic)</i>	
Residence		Residence	
6. ACCESSIBILITY TO PUBLIC:			
EXTERIOR VISIBLE FROM PUBLIC ROAD		INTERIOR ACCESSIBLE	
<input checked="" type="checkbox"/> Yes <input type="checkbox"/> No		<input type="checkbox"/> Yes <input checked="" type="checkbox"/> No	
		IF YES, EXPLAIN

7. STYLE OF BUILDING		DATE OF CONSTRUCTION	
Bungalow		1921-1924	
8. MATERIAL(S) <i>(Indicate use or location when appropriate)</i>			
<input type="checkbox"/> Clapboard	<input type="checkbox"/> Asbestos Siding	<input type="checkbox"/> Brick	<input type="checkbox"/> Other <i>(Specify)</i> _____
<input type="checkbox"/> Wood Shingle	<input type="checkbox"/> Asphalt Siding	<input type="checkbox"/> Fieldstone	
<input type="checkbox"/> Board & Batten	<input type="checkbox"/> Stucco	<input type="checkbox"/> Cobblestone	
<input checked="" type="checkbox"/> Aluminum Siding	<input type="checkbox

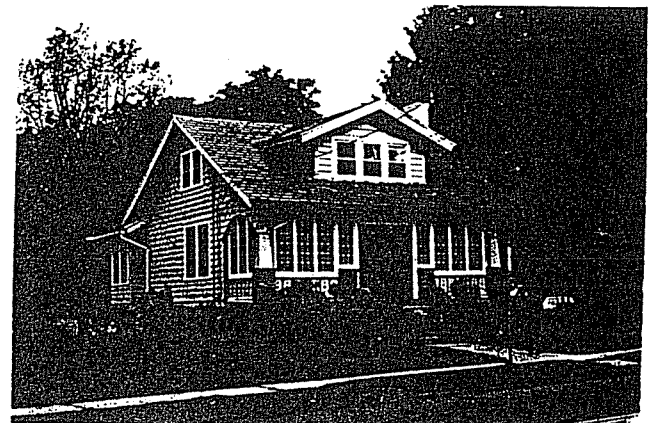
PHOTOGRAPHER	DATE
Peter Hall	6/83
VIEW	NEGATIVE ON FILE
E. side	3:28

Porch roof, is supported by two short, battered piers which rise from cobblestone pedestals. A gabled 3-window dormer is above the porch.

This 1½ story, 1920's bungalow has a balloon frame with a gable ridge-to-street slate roof and aluminum siding. The enclosed full-length sun porch has multi-pane windows joined at the top by a continuous semi-ellipse. The porch roof, a continuation of the main roof, is supported by two short battered piers (with extreme entasis) which rise from cobblestone pedestals. The 2-leaf, 5-pane doors are in the center of the porch. All house windows are 1/1 sash. A gabled 3 window dormer is centrally placed above the porch. A painted, corbelled exterior chimney is on the north side.
