STATE OF CONNECTICUT
 CONNECTICUT HISTORICAL COMMISSION
 59 SOUTH PROSPECT STREET, HARTFORD, CONNECTICUT 06106
 (203) 566-3005

1. BUILDING NAME (Common) (Historic)		Scranton, William S., House	
2. TOWN CITY	VILLAGE	COUNTY	
Durham		Middlesex	
3. STREET AND NUMBER (and or location)			
135 Main Street			
4. OWNER(S)			
Korn, Myra D. <input type="checkbox"/> Public <input checked="" type="checkbox"/> Private			
5. USE (Present)		(Historic)	
Residence		Residence	
6. ACCESSIBILITY TO PUBLIC:	EXTERIOR VISIBLE FROM PUBLIC ROAD	INTERIOR ACCESSIBLE	IF YES, EXPLAIN
<input checked="" type="checkbox"/> Yes <input type="checkbox"/> No	<input type="checkbox"/> Yes <input checked="" type="checkbox"/> No	<input type="checkbox"/> Yes <input checked="" type="checkbox"/> No

The 2 story, 2 bay, cross-gable William Scranton House was built in 1870. Its post-and-beam frame has an entry in the south side ell, is aluminum sided, and rests on a mortared sandstone foundation. The roof is asphalt-shingled.

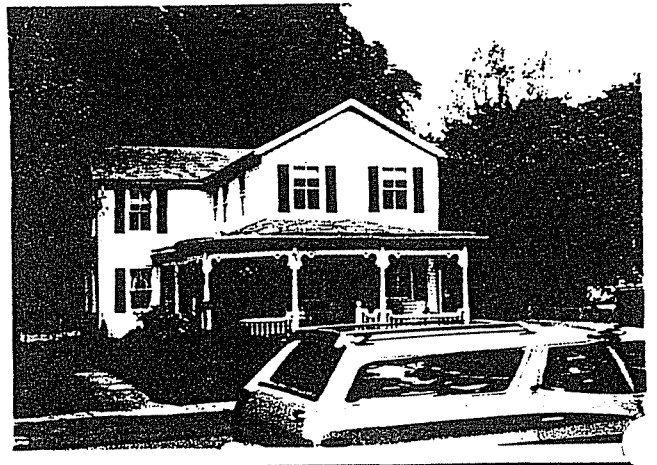
VIEW: from east NEGATIVE ON FILE: 3:29

The most distinctive feature of this house is its wide, hip-roofed, wrap-around verandah which runs the length of the facade, and returns to the south ell. Characterized by a projecting curve at the southeast corner it has an irregular top balustrade with turned balusters, sawn scroll brackets, and turned posts. The full-size, louvre-shuttered windows of the house contain 2/2 sash.
