STATE OF CONNECTICUT
 CONNECTICUT HISTORICAL COMMISSION
 59 SOUTH PROSPECT STREET, HARTFORD, CONNECTICUT 06106
 (203) 566-3005

1. BUILDING NAME (Common) (Historic)	
Hull, Andrew, Homestead	
2. TOWN CITY Durham	VILLAGE COUNTY Middlesex
3. STREET AND NUMBER (and or location) 114 Main Street	
4. OWNER(S) Cook, Gregory M. <input type="checkbox"/> Public <input checked="" type="checkbox"/> Private	
5. USE (Present) (Historic) Residence Residence	
6. ACCESSIBILITY TO PUBLIC: <input checked="" type="checkbox"/> Yes <input type="checkbox"/> No	EXTERIOR VISIBLE FROM PUBLIC ROAD <input type="checkbox"/> No
INTERIOR ACCESSIBLE <input checked="" type="checkbox"/> Yes <input type="checkbox"/> No	IF YES, EXPLAIN With Permission

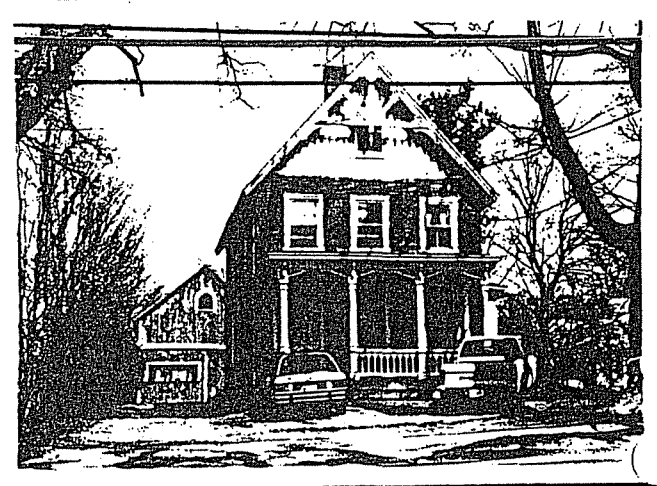
- Eastlake-Style porch supported by turned posts and decoratively sawn brackets
- posts are joined by a decoratively sawn balustrade
- gable peak contains stickwork brackets

This 2½ story, Victorian Stick-Style house stands on a cut sandstone block foundation with its gable end facing the street. Its facade contains a 1 story shed-roofed Eastlake-Style porch supported by turned posts and decoratively sawn brackets. The posts are joined by a decoratively sawn balustrade (which is identical to the balustrade on the Gaylord Newtown house on Maiden Lane). The front door is an original to the house, containing four panels defined by thick projecting moldings. The gable peak is ornamented with sawn and cut and sunk vertical board sheathing and contains stickwork brackets. A five sided bay on the south side of the house may date from its original construction. This feature has been marred by the replacement door, which dates from the mid-twentieth century. Two rear additions date from a 1960 remodeling of the structure. This house was built by Andrew Hull (1825-90) in 1877-78 on land purchased by the Hull family from the Seth Seward Estate. The house remained in the Hull family until 1967, one of a group of three contiguous houses in its possession (110,112,114 Main St.) This house is unquestionable one of the best examples of Victorian architecture in Durham. It is of particular importance because it is one of the few houses which can be definitely associated with a particular builder--Andrew Hull, the man who occupied it. It tells us a great deal about the taste and aspirations of late-nineteenth-century artisans and may prove to be an important key to understanding residential building in Durham during this period.
