**HISTORIC RESOURCES INVENTORY  
BUILDING AND STRUCTURES**

1. BUILDING NAME (Common) <i>(Historic)</i> Fairchild House/Spelman Hotel	
2. TOWN CITY Durham	VILLAGE COUNTY Middlesex
3. STREET AND NUMBER (and or location) Main Street and Wallingford Road, NW corner

Fairchild House/Spelman Hotel - p.2 (cont'd.)

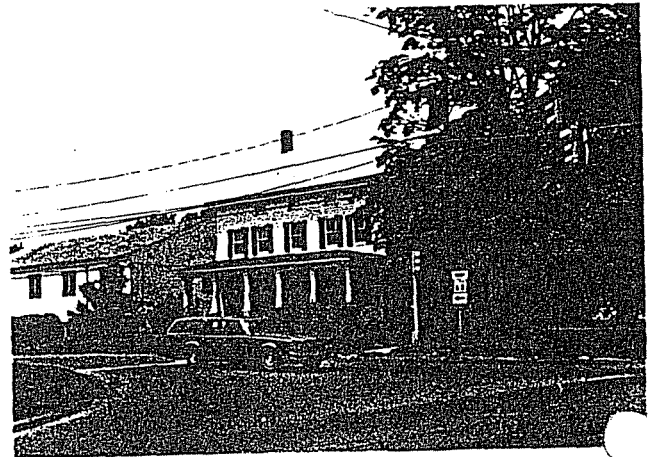
PHOTOGRAPHER		DATE	
Peter Hall		6/83	
VIEW	NEGATIVE ON FILE		
From SE			6:22
NAME		DATE	
J. McCord		8/83	
ORGANIZATION			
Greater Middletown Preservation Trust			
ADDRESS			
27 Washington St., Middletown, CT 06457

The original gambrel roof was replaced by a gable roof with Greek Revival style full pediments and entablature. Eyebrow windows mark the latter. The central facade doorway is framed by architrave moulding. A full-length, hip-roofed facade porch is supported by six square columns which rise from chamfered pedestals with recessed panels. The full-size 2/2 sash windows are flanked by louvered shutters. A 1 1/2 story ell has been added to the northeast corner. Also on the rear of the house is a newer, single-story, shed-roof addition.

The five-bay, central-hall plan Fairchild House/Spelman Hotel, on the west side of Main Street, is a Colonial period building (erected ca. 1740) with substantial mid-nineteenth-century Greek Revival style alterations. In its present form, the wooden post-and-beam frame of the 2 1/2 story, double chimney house has an asphalt-shingled gable roof, is sheathed in clapboarding, and rests on a sandstone/brick foundation.
