**HISTORIC RESOURCES INVENTORY**  
**BUILDING AND STRUCTURES**  
 HIST-6 NEW.5 77

1. BUILDING NAME (Common) (Historic)  
 Nettleton, Samuel C., House

2. TOWN/CITY: Durham VILLAGE: COUNTY: Middlesex

3. STREET AND NUMBER (and or location)  
 Cherry Lane, southside

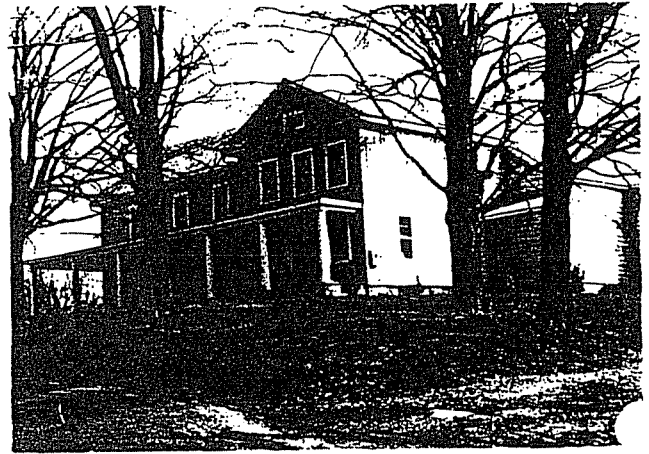
PHOTOGRAPHER	DATE
Alex Parades	5/84
VIEW	NEGATIVE ON FILE
SE	10:14
NAME	DATE
E.R. Hart	1/84
ORGANIZATION	
Greater Middletown Preservation Trust	
ADDRESS	
27 Washington St., Middletown, Conn. 06457

A large 2½ story, three-bay, ridge-to-street, gable-roofed ell extends from the eastern elevation. The single-story open porch extending the full length of the facade and ell displays simple Doric columns supporting a shed-roof. It is most probable that the first floor of the main block originally exhibited a three-bay side hall plan symmetrical with the three second-story windows. The facade gable-end features slight cornice returns and a three-paned, rectangular window. The present facade entrance is located centrally on the eastern ell. A number of large additions have been added to the southern elevation. A number of outbuildings are located on the grounds, the most prominent being a large, three-story, gambrel-roof barn.

Oriented gable-to-street, this 2½-story, Greek Revival-style structure was erected in 1857. Anchoring its wood-shingled, post-and-beam frame is a foundation of sandstone. The gable-roof is asphalt-shingled.
