**HISTORIC RESOURCES INVENTORY
BUILDING AND STRUCTURES**
HIST-6 NEW 5 77

IDENTIFICATION	1. BUILDING NAME (Common) (Historic)	
	Daniel Hall House Hall-Camp House	
	2. TOWN CITY	VILLAGE
	Durham	
	3. STREET AND NUMBER (and or location)	
	61/63 Main Street

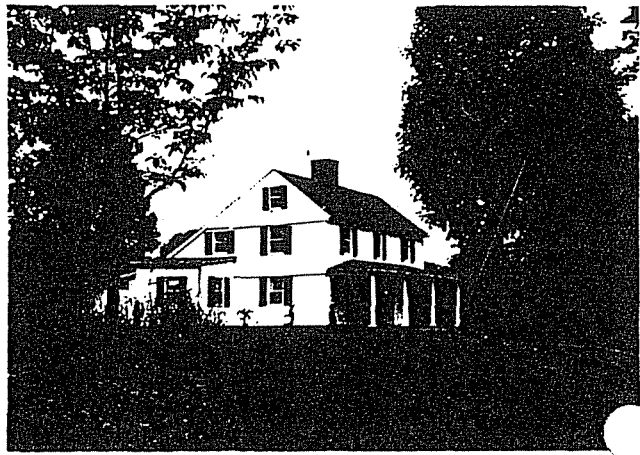
VIEW
from SE

Two one-over-one windows flank a modern, centrally located, projecting, enclosed entranceway. The full-length, hip-roofed facade porch is supported by four columns, marked by a slight entasis. Although both the porch and enclosed entranceway are clearly later additions, the rear lean-to and the central chimney are probably both original. Additions have been made to the northwest and southwest corners.
