HISTORIC RESOURCES INVENTORY
BUILDING AND STRUCTURES
 HIST-6 NEW 5 77

IDENTIFICATION	1. BUILDING NAME (Common) <i>(Historic)</i> The Grange Methodist Episcopal Church/Grange Hall	
	2. TOWN CITY Durham	VILLAGE COUNTY Middlesex

3. STREET AND NUMBER (and or location) 52 Main Street (East Side)	
	4. OWNER(S) Durham Grange <input type="checkbox"/> Public <input checked="" type="checkbox"/> Private

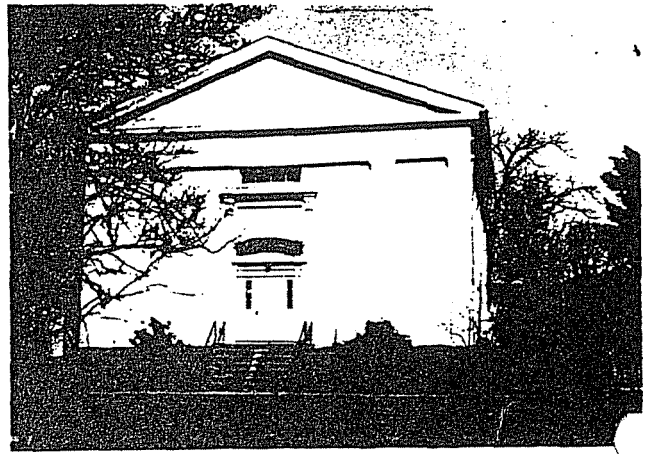
PHOTO	PHOTOGRAPHER	DATE
	P.D. Hall	Summer 1983
COMPILED BY	VIEW	NEGATIVE ON FILE
	East	III:33
	NAME	DATE
	I. Heublein	8/3/83
	ORGANIZATION	
Greater Middletown Preservation Trust		
ADDRESS		
27 Washington St., Middletown, Conn. 06457

17 OTHER NOTABLE FEATURES OF BUILDING OR SITE (interior and/or exterior)
 The facade is marked by a central doorway flanked by 4 full-length pilasters rising to a full pedimented gable end. These vertical flushboard pilasters rest on a plain wide water table and have moulded capitals. Five pilasters interspersed by four large rectangular shuttered windows adorn the north and south sides. Changes which have been made include the removal of the square church tower and the alterations made to the entryway. The central entrance once had a wide, single-panelled, double-leaf door flush with the facade and trimmed with plain moulding. Today there is a single six-panelled door recessed slightly back from the facade and flanked by three paned sidelights over a single panelled base as well as two slender fluted pilasters. Directly above the doorway is a plain architrave and crown moulded cornice with dentil moulding. Surmounting the entrance are two large single panels, where windows were originally located. (CONT. BELOW)

17 (cont'd)
 These panels are capped by a projecting square dovehood supported by two foliated scrolled consoles. Lastly, a four-paned transom, just under the wide entablature, completes the entryway.
