**HISTORIC RESOURCES INVENTORY
BUILDING AND STRUCTURES**

IDENTIFICATION	1. BUILDING NAME (Common) (Historic) Post Office	
	2. TOWN/CITY Durham	VILLAGE COUNTY Middlesex
	3. STREET AND NUMBER (and or location) 46 Main St. (East side)

7. STYLE OF BUILDING Nineteenth century Public Building style	
	DATE OF CONSTRUCTION ca. 1852	
	8. MATERIAL(S) (Indicate use or location when appropriate)	
	<input type="checkbox"/> Clapboard <input type="checkbox"/> Asbestos Siding <input type="checkbox"/> Brick <input type="checkbox"/> Other (Specify) _____ <input checked="" type="checkbox"/> Wood Shingle <input type="checkbox"/> Asphalt Siding <input type="checkbox"/> Fieldstone <input type="checkbox"/> Board & Batten <input type="checkbox"/> Stucco <input type="checkbox"/> Cobblestone <input type="checkbox"/> Aluminum Siding <input checked="" type="checkbox"/> Concrete Type: Foundation <input checked="" type="checkbox"/> Cut stone Type: Foundation: Sandstone, irregularly coursed	
DESCRIPTION	9. STRUCTURAL SYSTEM	
	<input checked="" type="checkbox"/> Wood frame <input type="checkbox"/> Post and beam <input checked="" type="checkbox"/> balloon <input type="checkbox"/> Other (Specify) _____ <input typ

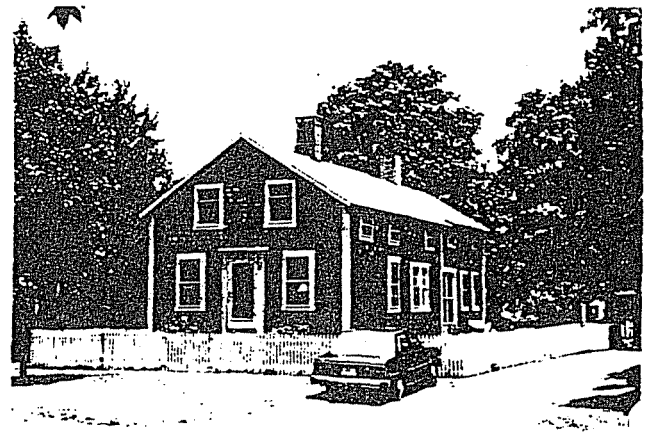
PHOTOGRAPHER	DATE
P.D. Hall	Summer 1983
VIEW	NEGATIVE ON FILE
Front-West Side	III:36
NAME	DATE
I. Heublein	8/2/83
ORGANIZATION	
Greater Middletown Preservation Trust	
ADDRESS	
27 Washington St., Middletown, Conn. 06457

This building was moved to this lot on Main Street in 1857. An early photograph in Whited's Durham's Heritage, p. 106, shows the building soon after it was built. It is clear that alterations have been made. Today the west facade is marked by a central doorway with a plain frame and topped by a crown-moulded cornice, a later addition. The fenestration pattern has been changed. The two windows in the gable were originally located directly over the two windows flanking the doorway below. Earlier, the building had three symmetrically placed operable windows on either side, topped by three eyebrow windows. There is an east gable-roofed, center-chimney addition with a south screened porch irregularly punctuated by windows and doors. This addition rests on a concrete foundation.

David Smith built this 1½ story balloon-frame building about 1850. It is oriented gable-to-street, is covered with stained wooden shingles, and rests on a high random-coursed sandstone foundation. A central chimney caps the slate-covered gable roof.
