**HISTORIC RESOURCES INVENTORY
BUILDING AND STRUCTURES**
HIST-6 NEW 5 77

IDENTIFICATION	1. BUILDING NAME (Common) <i>(Historic)</i> Austin Ackeman House		David, Henry, House	
	2. TOWN CITY Durham		VILLAGE	COUNTY Middlesex
	3. STREET AND NUMBER (and or location) 31 Main Street			
	4. OWNER(S) Ackeman, Jr., Austin <input type="checkbox"/> Public <input checked="" type="checkbox"/> Private			
	5. USE (Present) Residence		<i>(Historic)</i> Residence	
	6. ACCESSIBILITY TO PUBLIC:	EXTERIOR VISIBLE FROM PUBLIC ROAD <input checked="" type="checkbox"/> Yes <input type="checkbox"/> No	INTERIOR ACCESSIBLE <input checked="" type="checkbox"/> Yes <input type="checkbox"/> No	IF YES, EXPLAIN With Permission

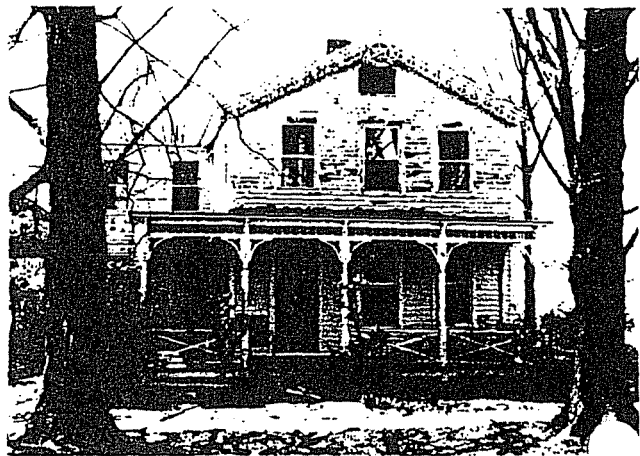
PHOTO

Stick style wrap-around porch with turned columns, sawn brackets and spindles.

The Ackerman-Davis House is a 2 story, side-hall entry, domestic vernacular structure with Eastlake ornamentation. The main block is a 2 story gable roofed structure with the gable-end facing the street. An open, wrap-around porch on the east and south sides is supported by turned columns and sawn brackets. The columns are joined by spandrels with turned spindle and a stick-style balustrade. The front door, a turn of the century replacement, is wood panelled with a large plate glass pane in its upper section. The windows in the main block are two-over-two, double hung sash. The house has had two major additions. The first is a two story shed roofed 12'x12' addition to the south side. This appears to date from the turn of the century. The second is a one story shed roof addition to the northwest corner. It measures 15'x19' and appears from its concrete foundation to date from the twentieth century. There is a rear entry with an open and enclosed porch to the rear of the south side addition. This house was built for Henry Davis, proprietor of Davis' Store on land purchased from William H. Canfield in 1877. It was built between 1877 and 1881. Davis, long-time Durham storekeeper and sometime postmaster, sold the house to Austin M. Ackerman in 1927. It remains in the Ackerman family. This house is a fine example of late nineteenth-century domestic architecture. Its well-preserved Eastlake-style porch is especially notable. Its historical significance derives from its association with Henry Davis and the Ackermans, leaders of Durham's community life in the nineteenth and twentieth centuries.

VIEW: W NEGATIVE ON FILE: 11:8
