STATE OF CONNECTICUT
 CONNECTICUT HISTORICAL COMMISSION
 59 SOUTH PROSPECT STREET, HARTFORD, CONNECTICUT 06106
 (203) 566-3005

1. BUILDING NAME (Common) <i>(Historic)</i>	
Page, Frederick H., House	
2. TOWN CITY	VILLAGE COUNTY
Durham	Middlesex
3. STREET AND NUMBER (and or location)	
21 Main Street	
4. OWNER(S)	
Kowalski, Walter E., Trustee <input type="checkbox"/> Public <input checked="" type="checkbox"/> Private	
5. USE (Present) <i>(Historic)</i>	
Residence/Real Estate office Residence	
6. ACCESSIBILITY TO PUBLIC:	EXTERIOR VISIBLE FROM PUBLIC ROAD INTERIOR ACCESSIBLE IF YES EXPLAIN
<input checked="" type="checkbox"/> Yes <input type="checkbox"/> No	<input checked="" type="checkbox"/> Yes <input type="checkbox"/> No During business hours

7. STYLE OF BUILDING	DATE OF CONSTRUCTION
Bungalow	c. 1920
8. MATERIAL(S) <i>(Indicate use or location when appropriate)</i>	
<input checked="" type="checkbox"/> Clapboard <input type="checkbox"/> Asbestos Siding <input type="checkbox"/> Brick <input type="checkbox"/> Other <i>(Specify)</i> <input type="checkbox"/> Wood Shingle <input type="checkbox"/> Asphalt Siding <input type="checkbox"/> Fieldstone <input type="checkbox"/> Board & Batten <i

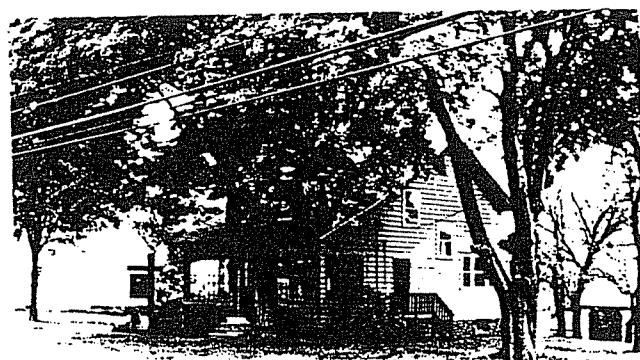
This handsome bungalow stands on a picturesque cobblestone foundation. Constructed with a balloon frame, it is sheathed with wide blue-painted clapboards. Although surmounted by a two-pitch gable roof, like many similar houses of the 1920s and 30s in Durham, the living space in the second story is expanded by full-length dormers on the second story, which functionally transform the second floor into full-size living space. The house is fronted by a full-size sun porch with multi-paned picture windows on its first story facade. The dormers contain small 3x1 windows. The south side contains a 1 story, 3 sided rectangular bay. To the rear of the house stands a gable roofed 2 car garage contemporary with the main structure. This is one of three houses at the southern end of Main Street associated with the William A. Parsons family. In 1913, Harold C. Parsons, the metal manufacturer, bought 2½ acres from Robert B. Meigs and Grace Amelia Camp. This land was located south of his own home at 31 Main Street. In 1921, he sold 1 1/6 acres to his brother-in-law, Frederick H. Page, husband of his sister Gertrude. They built a house on the property shortly afterwards. In 1946, the Pages gave the property to their daughter and her husband, Catherine and Homer McNutt of Philadelphia, who sold the property in 1971. With its unspoiled site, this bungalow is an excellent example of the homebuilding and landscaping of the post World War I period. Historically, it is an interesting example of Durham's social conservatism, the tendency of families to cluster their residences as they had in the 18th and 19th centuries.

PHOTOGRAPHER	Hall, Peter Dobkin	DATE	10 JUN 1983
VIEW	N & E elevations	NEGATIVE ON FILE	2:33A
NAME	Hall, Peter Dobkin	DATE	20 AUG 1983
ORGANIZATION	Greater Middletown Preservation Trust, Inc.		
ADDRESS	27 Washington Street, Middletown, Conn., 06457
