**HISTORIC RESOURCES INVENTORY  
BUILDING AND STRUCTURES**  
HIST-6 NEW 5-77

IDENTIFICATION	1. BUILDING NAME (Common) <span style="float: right;">(Historic)</span>	
	Fowler, John A., House	
	2. TOWN CITY Durham	VILLAGE COUNTY Middlesex

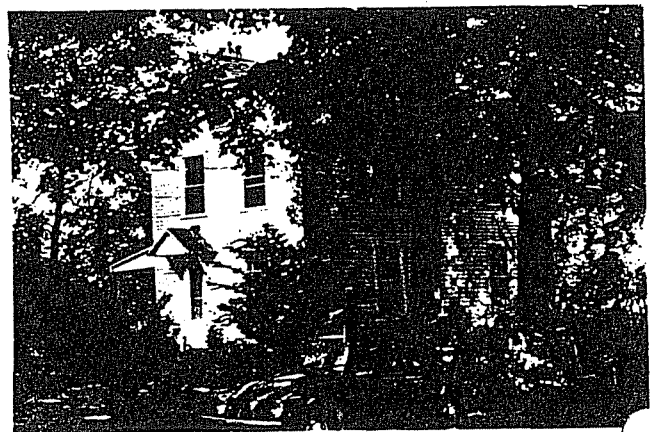
VIEW SW NEGATIVE ON FILE 6:2

This modest two-bay house is marked with a west doorway covered by a gabled door hood supported by stick style brackets. The west side has a single story shed-roofed open porch which is enclosed on the northwest corner. The southwest porch is supported by four thin square posts.

John A. Fowler built this two story, clapboarded, balloon frame nineteenth-century domestic style house in 1872. Resting on a sandstone foundation, the house is oriented gable-to-street and capped by an asphalt-shingled roof with center chimney.
