HISTORIC RESOURCES INVENTORY
BUILDING AND STRUCTURES
 HIST-6 NEW 5 77.

IDENTIFICATION	1. BUILDING NAME (Common) (Historic)	
	Hubbard Workers' Housing #1	
	2 TOWN CITY	VILLAGE COUNTY
	Durham	Middlesex
	3 STREET AND NUMBER (and or location)	
	Maple Avenue	
	4 OWNER(S)	
	Stevens, Wilson & Edith <input type="checkbox"/> Public <input checked="" type="checkbox"/> Private	
	5 USE (Present) (Historic)	
	Residence Residence	
	6 ACCESSIBILITY TO PUBLIC:	EXTERIOR VISIBLE FROM PUBLIC ROAD INTERIOR ACCESSIBLE IF YES EXPLAIN
	<input checked="" type="checkbox"/> Yes <input type="checkbox"/> No	<input type="checkbox"/> Yes <input checked="" type="checkbox"/> No
	7 STYLE OF BUILDING	DATE OF CONSTRUCTION
	19th Century Domestic	ca. 1895
	8 MATERIAL(S) (Indicate use or location when appropriate)	
	<input type="checkbox"/> Clapboard <input type="checkbox"/> Asbestos Siding <input type="checkbox"/> Brick <input type="checkbox"/> Other (Specify) _____ <input type="checkbox"/> Wood Shingle <input checked="" type="checkbox"/> Asphalt Siding <input type="checkbox"/> Fieldstone <input type="checkbox"/> Board & Batten <input type="checkbox"/> Stucco <input type="checkbox"/> Cobblestone <input type="checkbox

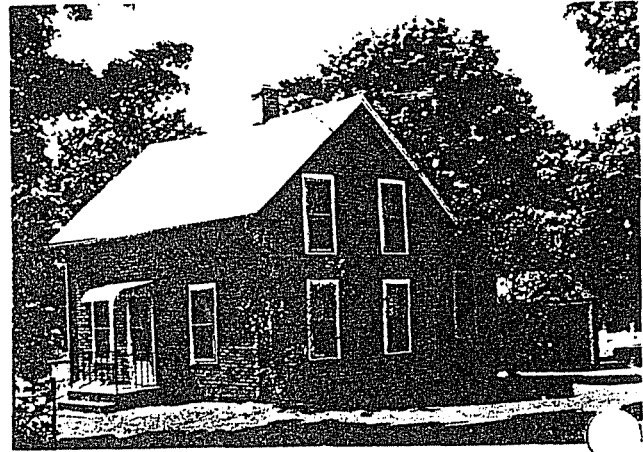
PHOTO

The north elevation features a modern sun porch and a one-story addition topped with a shed roof. Outbuildings on the lot include a one-car, gable-to-street garage and a small shed.

Built ca. 1895, this late-nineteenth-century domestic building utilizes a balloon framing system supported by a sandstone-rubble foundation. 1½ stories in height with a gable-to-street asphalt shingled roof, the house is sided in imitation brick vinyl. The 3 bay facade faces south away from the street and features a central doorway topped with a modern aluminum hood. The 2 bay east elevation with gable-end facing the street features two-over-two sash as does the rest of the house. In 1893, Oliver D. Hubbard, a local lumber dealer, purchased a nine and a half acre lot from Juliet W. Camp, upon which he erected this house and the house to the north (see: Oliver D. Hubbard Workers Housing #2). Hubbard, a native of Madison, Ct., built a number of rental homes at the end of the nineteenth-century presumably to house employees of his mills. In 1917, William Fowler purchased the property and within a year sold it to Howard B. Field of Springfield, Massachusetts. Field, who also rented the property, was responsible for dividing the lot into smaller portions, as it stands today. The house is typical of rental housing found during the late 1800s.

PHOTOGRAPHER	P.D. Hall	DATE	6/83
VIEW	NE	NEGATIVE ON FILE	5:14
