HISTORIC RESOURCES INVENTORY
BUILDING AND STRUCTURES

STATE OF CONNECTICUT
CONNECTICUT HISTORICAL COMMISSION
 59 SOUTH PROSPECT STREET, HARTFORD, CONNECTICUT 06106
 (203) 566-3005

1. BUILDING NAME (Common) (Historic)		Hubbard Workers' Housing #2	
2. TOWN CITY	VILLAGE	COUNTY	
Durham		Middlesex	
3. STREET AND NUMBER (and or location)			
Maple Avenue

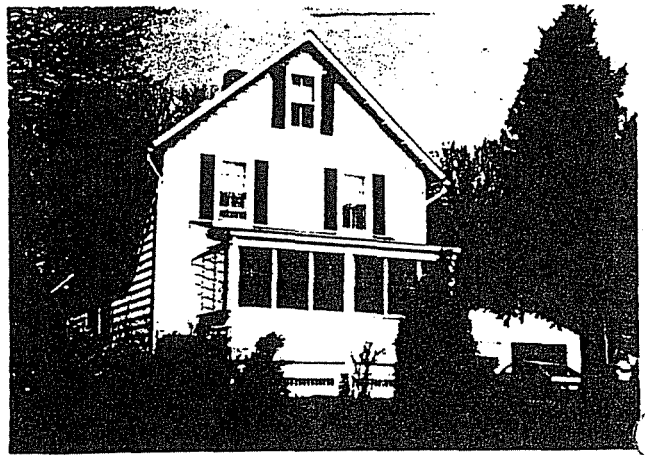
PHOTOGRAPHER	DATE
Peter Hall	6/83
VIEW	NEGATIVE ON FILE
NW	5:17
NAME	DATE
E.R. Hart	10/83
ORGANIZATION	
Greater Middletown Preservation Trust	
ADDRESS	
27 Washington St., Middletown, CT 06457

11. NUMBER OF STORIES		APPROXIMATE DIMENSIONS	
2		24'x20'; 16'x30'; 17'x12';	
12. CONDITION (Structural) (Exterior)			
<input type="checkbox"/> Excellent	<input type="checkbox"/> Good	<input checked="" type="checkbox"/> Fair	<input type="checkbox"/> Deteriorated
<input type="checkbox"/> Excellent	<input type="checkbox"/> Good	<input checked="" type="checkbox"/> Fair	<input type="checkbox"/> Deteriorated

13. INTEGRITY (Location)		WHEN ?	(Alterations) IF YES EXPLAIN
<input checked="" type="checkbox"/> On original site	<input type="checkbox"/> Moved		<input checked="" type="checkbox"/> Yes <input type="checkbox"/> No windows, shed roof

The facade features an open porch topped by a slightly pitched shed roof supported by tapered columns. The columns rest on concrete pedestals incorporated into a solid, asbestos-sided balustrade. A diminutive brick chimney is centrally located and an exposed concrete block chimney divides the facade. The north and south elevations both exhibit one-story, shed-roofed, additions. A large 1 story ell has been added to the rear.

Similar to other rental housing in the area, the Hubbard Workers' Housing #2 is a 2½ story, 2 bay, late-nineteenth-century domestic style building, erected ca. 1895. The aluminum-sided balloon frame rests on a brownstone foundation and is capped by a gable-to-street asphalt-shingled roof. Lumber merchant, Oliver D. Hubbard, erected this house and the dwelling to the south (see Hubbard Workers' Housing #1) on the same lot ca. 1895. Presumably Hubbard, who operated two local lumber/saw mills, erected these structures to house his employees. In 1917, Hubbard sold the property to farmer William Chauncey Fowler, grandson of William C. Fowler, author of the "History of Durham". In 1928 the large lot with dwellings was broken up and sold to individual owners. This house is important for its association with wealthy business merchant, Oliver D. Hubbard, as well as an early model of rental housing in Durham.
