**HISTORIC RESOURCES INVENTORY
BUILDING AND STRUCTURES**

1. BUILDING NAME (Common) (Historic)	
Hull, Harvey, House	
2. TOWN CITY	COUNTY
Durham	Middlesex
3. STREET AND NUMBER (and or location)	
Mica Hill Road, Southeast side	
4. OWNER(S)	
Giulietti, George L. <input type="checkbox"/> Public <input checked="" type="checkbox"/> Private	
5. USE (Present) (Historic)	
Residence Residence	
6. ACCESSIBILITY TO PUBLIC:	IF YES, EXPLAIN
<input checked="" type="checkbox"/> Yes <input type="checkbox"/> No

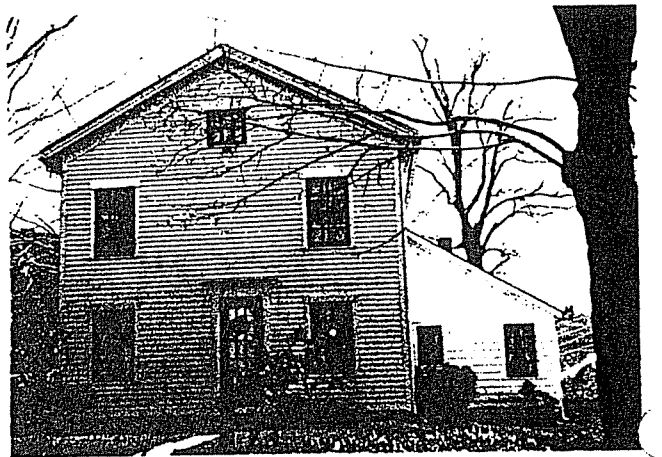
PHOTOGRAPHER	DATE
Alex Parades	5/84
VIEW	NEGATIVE ON FILE
Facing SW	13:11
NAME	DATE
L. Hart	2/84
ORGANIZATION	
Greater Middletown Preservation Trust	
ADDRESS	
27 Washington St., Middletown, Conn. 06457

A plain trim doorway with a thin projecting cornice is placed slightly south of the facade center. A notable feature is the irregular placement of the facade entrance door which indicates that this is apparently not a balloon-frame structure. Four six-over-six windows are placed symmetrically on the facade. The gable end exhibits a square, six-paned sash. Additions include a single-story, gable-roofed ell to the rear and a single-story, shed-roofed ell on the west elevation. Multiple outbuildings include two barns, an ice house and milk house. A small, manmade pond is located to the northeast of the main house.

Built in 1860, this 2½ story, gable-to-street, mid-nineteenth-century domestic style farmhouse is set on Mica Hill as it rises to the south. Topped with an asphalt-shingled roof, the clapboarded post-and-beam frame rests on a coursed sandstone foundation.
