**HISTORIC RESOURCES INVENTORY
BUILDING AND STRUCTURES**

IDENTIFICATION	1. BUILDING NAME (Common) <i>Gastler Farm</i> (Historic) <i>Miller, John W., House</i>	
	2. TOWN CITY <i>Durham</i>	VILLAGE _____ COUNTY <i>Middlesex</i>
	3. STREET AND NUMBER (and or location) <i>Middlefield Road</i>	
	4. OWNER(S) <i>Gastler, Elsie & Charles; Hicks, Marjorie</i> <input type="checkbox"/> Public <input checked="" type="checkbox"/> Private	
	5. USE (Present) <i>Residence</i> (Historic) _____

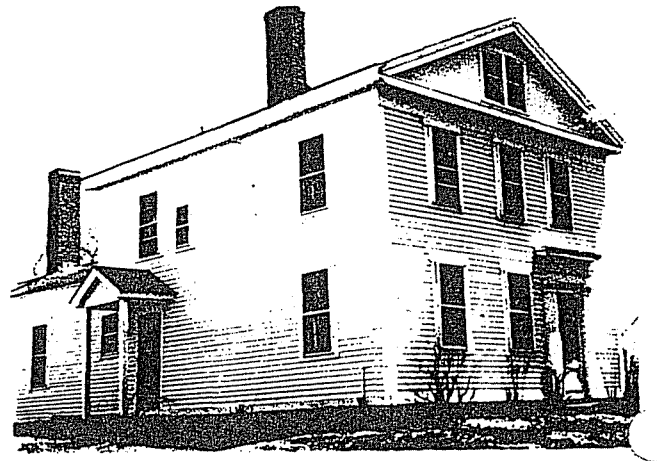
PHOTOGRAPHER		DATE	
Alex Parades		5/84	
VIEW	NEGATIVE ON FILE		
SE	13:2		
NAME		DATE	
E.R. Hart		4/84	
ORGANIZATION			
Greater Middletown Preservation Trust			
ADDRESS			
27 Washington St., Middletown, Conn. 06457

The side-hall-plan facade features three bays. The flushboarded main gable end is fully pedimented and displays a paired set of six-over-six sash. The facade entrance-way is executed in the Greek Revival style with high entablature set over side pilasters. Original six-over-six sash remain. A single story gable-roofed ell projects from the east elevation. A number of outbuildings are found on the property.

The John W. Miller House is a 2½ story, gable-to-street, Greek Revival-style building. Erected ca. 1845, the clapboarded structure is supported by a post-and-beam framing system which rests on a brownstone foundation.
