**HISTORIC RESOURCES INVENTORY
BUILDING AND STRUCTURES**

1. BUILDING NAME (Common)	(Historic)	Camp, Enoch F., House
2 TOWN CITY	VILLAGE	COUNTY
Durham		Middlesex
3 STREET AND NUMBER (and or location)		
266 New Haven Road, West side		
4 OWNER(S)		
Schmitt, Donald F., Jr. & Julie Jr. <input type="checkbox"/> Public <input checked="" type="checkbox"/> Private		
5 USE (Present)		
Residence (Historic) Residence		
6. ACCESSIBILITY TO PUBLIC:	EXTERIOR VISIBLE FROM PUBLIC ROAD	INTERIOR ACCESSIBLE
<input checked="" type="checkbox"/> Yes <input type="checkbox"/> No	<input type="checkbox"/> Yes <input checked="" type="checkbox"/> No	IF YES EXPLAIN

7 STYLE OF BUILDING	DATE OF CONSTRUCTION
Nineteenth-century domestic cape	ca.1850
8. MATERIAL(S) (Indicate use or location when appropriate)	
<input type="checkbox"/> Clapboard <input type="checkbox"/> Asbestos Siding <input type="checkbox"/> Brick <input type="checkbox"/> Other (Specify)	
<input checked="" type="checkbox"/> Wood Shingle <input type="checkbox"/> Asphalt Siding <input type="checkbox"/> Fieldstone	
<input type="checkbox"/> Board & Batten <input type="checkbox"/> Stucco <input type="checkbox"/> Cobblestone	
<input type="checkbox"/> Al

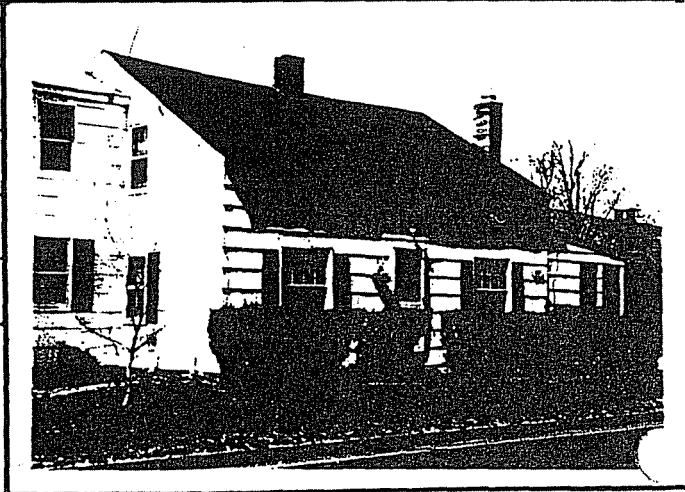
PHOTO	PHOTOGRAPHER Alex Parades	DATE 5/84
	VIEW northwest	NEGATIVE ON FILE 14:7
COMPILED BY	NAME E.R. Hart	DATE 4/83
	ORGANIZATION Greater Middletown Preservation Trust	
	ADDRESS 27 Washington St., Middletown, Conn. 06457

Considerably altering its original appearance are the many additions annexed to the north, west and south elevations. The most imposing addition is the 2½ story ell added to the south elevation which doubles the size of the house. Additions to the north elevation include a single story ell and a shed-roofed enclosed porch. A modern sun porch was recently constructed on the south west corner of the house. The original block features eight-over-eight sash on the facade and an original eight-over-twelve sash in the gable end. The facade exhibits a modern aluminum door trimmed with a simple frame. Several outbuildings are located on the property including a large barn with slate roof.

Constructed about 1850, this 1½ story, mid-nineteenth-century farmhouse sits on the west side of New Haven Road in the southwestern portion of Durham. Featuring a three-bay facade, the building is supported by a post-and-beam framing system resting on a sandstone foundation. Presently sided with wood shingles, the house is capped by an asphalt-shingled, ridge-to-street gable roof.
