**HISTORIC RESOURCES INVENTORY
BUILDING AND STRUCTURES**

HIST-6 NEW 5 77

1. BUILDING NAME (Common)		(Historic)	
Durham		Parmelee, Willis I, House	
2. TOWN CITY	VILLAGE	COUNTY	
Durham		Middlesex	
3. STREET AND NUMBER (and or location)			
Parmelee Hill Road, South side			
4. OWNER(S)			
Parmelee, Richard C. <input type="checkbox"/> Public <input checked="" type="checkbox"/> Private			
5. USE (Present)		(Historic)	
Residence		Residence	
6. ACCESSIBILITY TO PUBLIC:	EXTERIOR VISIBLE FROM PUBLIC ROAD	INTERIOR ACCESSIBLE	IF YES, EXPLAIN
<input checked="" type="checkbox"/> Yes <input type="checkbox"/> No	<input checked="" type="checkbox"/> Yes <input type="checkbox"/> No	<input checked="" type="checkbox"/> Yes <input type="checkbox"/> No	with permission

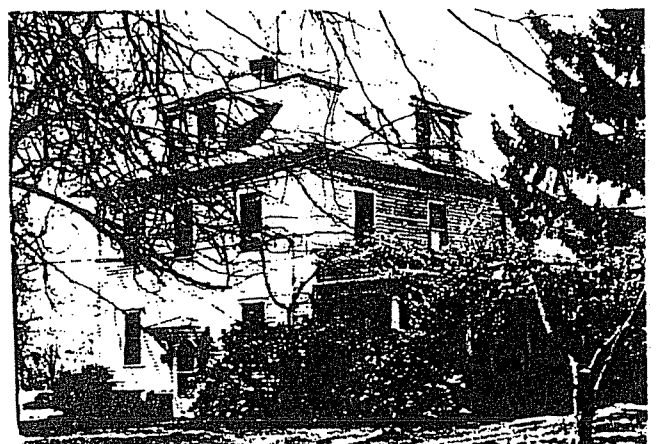
PHOTO	PHOTOGRAPHER	DATE
	Alex Parades	5/84
COMPILED BY	VIEW	NEGATIVE ON FILE
	southeast	13:17
COMPILED BY	NAME	DATE
	E.R. Hart	4/84
	ORGANIZATION	
Greater Middletown Preservation Trust		
ADDRESS		
27 Washington St., Middletown, Conn. 06457

The three-bay facade features a balustraded veranda with centered pediment above the main entrance. The porch as it wraps around the east side is enclosed and on the southeast corner features an enclosed screened porch. The facade door surround exhibits a moulded cornice supported by fluted pilasters. The elegant entrance door displays a full-length oval glass pane. Large attic dormers are featured on all slopes of the roof and the one-over-one sash are set in plain trim topped with a simple moulded cornice. A large barn with slate roof is located to the south of the house.

Prominently situated upon Parmelee Hill overlooking the valley to the east is the Willis I. Parmelee House. Erected in 1909-1910, this 2½ story Colonial Revival dwelling is topped with a slate-shingled, hip roof. The clapboarded balloon frame is supported by a traprock foundation.
