HISTORIC RESOURCES INVENTORY
BUILDING AND STRUCTURES
 HIST-6 NEW 5 77

STATE OF CONNECTICUT
CONNECTICUT HISTORICAL COMMISSION
 59 SOUTH PROSPECT STREET, HARTFORD, CONNECTICUT 06106
 (203) 566-3005

1. BUILDING NAME (Common) <i>(Historic)</i>		Atwell, George, House	
2. TOWN CITY	VILLAGE	COUNTY	
Durham		Middlesex	
3. STREET AND NUMBER (and or location)			
South End Ave., West side			
4. OWNER(S)			
Wiatrak, Alex & Susan <input type="checkbox"/> Public <input checked="" type="checkbox"/> Private			
5. USE (Present) <i>(Historic)</i>			
Residence		Residence	
6. ACCESSIBILITY TO PUBLIC: EXTERIOR VISIBLE FROM PUBLIC ROAD INTERIOR ACCESSIBLE IF YES, EXPLAIN			
<input checked="" type="checkbox"/> Yes <input type="checkbox"/> No	<input type="checkbox"/> Yes <input checked="" type="checkbox"/> No

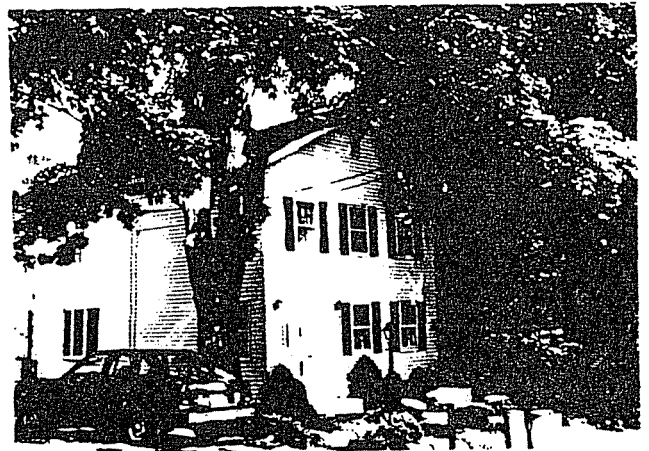
VIEW	Facing NW	NEGATIVE ON FILE	7:9
------	-----------	------------------	-----

11. NUMBER OF STORIES		APPROXIMATE DIMENSIONS	
2 1/2		28' x 24'	
12. CONDITION <i>(Structural)</i> <i>(Exterior)</i>			
<input checked="" type="checkbox"/> Excellent	<input type="checkbox"/> Good	<input type="checkbox"/> Fair	<input type="checkbox"/> Deteriorated
<input checked="" type="checkbox"/> Excellent	<input type="checkbox"/> Good	<input type="checkbox"/> Fair	<input type="checkbox"/> Deteriorated

13. INTEGRITY <i>(Location)</i> WHEN? <i>(Alterations)</i> IF YES EXPLAIN			
<input checked="" type="checkbox"/> On original site	<input type="checkbox"/> Moved	<input checked="" type="checkbox"/> Yes <input type="checkbox"/> No	1 story shed roof ell to west elevation

The three-bay, side-hall-plan facade is highlighted by a six-panelled door framed by two thin vertical three-paned sidelights and topped with a thin molded cornice. Flanking the sidelights are thin fluted pilasters with molded cornices. Stylistically, it is most probable that the doorway is a later addition. Added to the rear of the house is a single story, shed-roofed ell. The six-over-six sash feature fixed louvered shutters.

This mid-nineteenth-century Domestic-style structure, reminiscent of the Greek-Revival style, was built in 1844 by George Atwell. The 2½ story building is oriented gable-to-street with an asphalt-shingled roof. Utilizing a post-and-beam framing system, it is covered in aluminum siding and sits on sandstone foundation.
