HISTORIC RESOURCES INVENTORY
BUILDING AND STRUCTURES

1. BUILDING NAME (Common) (Historic)
Hinman, James, Jr., House

2. TOWN CITY: Durham VILLAGE: COUNTY: Middlesex

7. STYLE OF BUILDING: Nineteenth-century domestic DATE OF CONSTRUCTION: ca. 1835

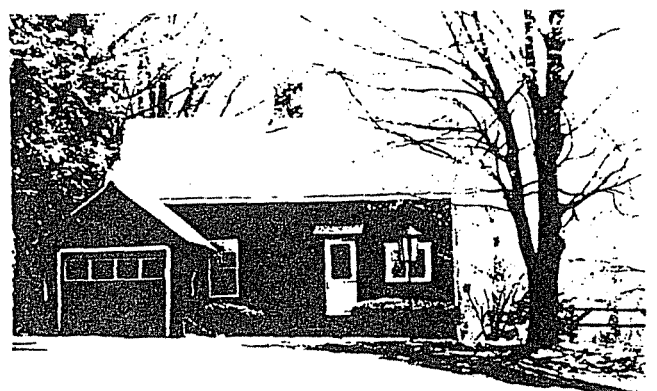
PHOTO

The facade features a central entry door topped with a modern, aluminum door hood. The entrance is flanked by a twelve-over-twelve sash on the east and a small, diamond-paned window on the west. A 1 story, 1 bay, gable-to-street garage has been added to the easternmost portion of the facade. The exposed basement on the western elevation is clapboarded and the original twelve-over-twelve sash are featured throughout the house.

The James Hinman, Jr. House is a 3 bay, 1½ story, nineteenth-century Domestic-style building erected ca. 1835. Built into the side of a hill, the basement is fully exposed on the west elevation. Resting on a brownstone foundation, the clapboarded post-and-beam frame is topped with a ridge-to-street gable roof.

VIEW S NEGATIVE ON FILE 13:9
