**HISTORIC RESOURCES INVENTORY
BUILDING AND STRUCTURES**

IDENTIFICATION	1. BUILDING NAME (Common) <i>(Historic)</i> Asman, William, House	
	2. TOWN CITY Durham	VILLAGE COUNTY Middlesex
	3. STREET AND NUMBER (and or location) 370 Wallingford Rd.

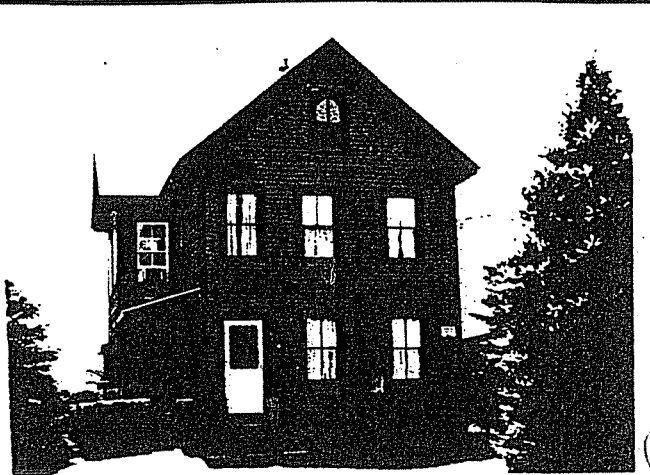
PHOTOGRAPHER		DATE	
Alex Parades		5/84	
VIEW	NEGATIVE ON FILE		
S	13:4		
NAME		DATE	
E. R. Hart		11/83	
ORGANIZATION			
Greater Middletown Preservation Trust			
ADDRESS			
27 Washington St., Middletown, Conn. 06457

Similar to other post-Civil War domestic structures in the area, the William Asman House exhibits characteristics of the Greek Revival style, including heavy cornice returns and broad overhanging eaves in the gable ends. Another popular feature in late-nineteenth-century domestic architecture is the rounded arched window displayed in the gable end. The facade entryway is enhanced by a simple flush door surround. The 1½ story rear ell is a modern addition. A garage and small outbuilding are located to the west and south of the main house.

Resting on a sandstone rubble foundation, this 2½ story, 3 bay, late-nineteenth-century domestic style building was built for William Asman in 1884. Capped with an asphalt-shingled, cross gable roof, the balloon frame is sided in clapboards.
