**NATIONAL RESOURCES INVENTORY
BUILDING AND STRUCTURES**

IDENTIFICATION	1. BUILDING NAME (Common) (Historic) Hull, Sylvanus, House	
	2. TOWN CITY Durham	COUNTY Middlesex
	3. STREET AND NUMBER (and or location) Madison Road, east side	
	4. OWNER(S) Wakeman, Betty and Alfred <input type="checkbox"/> Public <input checked="" type="checkbox"/> Private	
	5. USE (Present) (Historic) Residence Residence

7. STYLE OF BUILDING Center-chimney Colonial	DATE OF CONSTRUCTION ca. 1770
---	----------------------------------

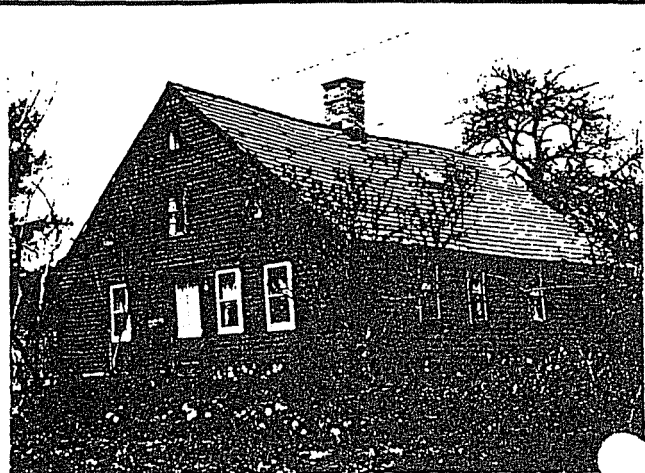
PHOTOGRAPHER Alex Parades	DATE 5/84
VIEW Northeast	NEGATIVE ON FILE 14:13
NAME E. R. Hart	DATE 5/84
ORGANIZATION Greater Middletown Preservation Trust	
ADDRESS 27 Washington Street, Middletown, CT 06457

The three-bay facade features an off-center entranceway with a late nineteenth-century door. The gable end exhibits three small four-paned windows placed triangularly around a larger six-over-six sash. This window placement is characteristic of local colonial-period Cape-style buildings. The first-floor sash have been replaced with modern one over-one windows. A number of outbuildings are located on the property.

This simple, 1½ story, colonial-period Cape-style dwelling was erected by Sylvanus Hull about 1770. Oriented gable-to-street, the clapboarded post-and-beam timbers rest on a fieldstone foundation. The house is capped by a wood-shingled gable roof which is topped by a modern brick chimney. Sylvanus (1746-1818), the son of Cornelius and Abigail (Chipman) Hull, probably built this house shortly after his marriage.
