HISTORIC RESOURCES INVENTORY
BUILDING AND STRUCTURES

IDENTIFICATION	1. BUILDING NAME (Common) <i>(Historic)</i> Luzerne Bristol House		Strong, T. B., House	
	2 TOWN CITY Durham		COUNTY Middlesex	
	3 STREET AND NUMBER (and or location) Maiden Lane, north side, .2 m east of Main Street			
	4 OWNER(S) Luzerne and Dorothy Bristol <input type="checkbox"/> Public <input checked="" type="checkbox"/> Private			
	5 USE (Present) Residence		<i>(Historic)</i> Residence	
	6 ACCESSIBILITY TO PUBLIC: <input checked="" type="checkbox"/> Yes <input type="checkbox"/> No		EXTERIOR VISIBLE FROM PUBLIC ROAD <input type="checkbox"/> Yes <input type="checkbox"/> No	
		INTERIOR ACCESSIBLE <input checked="" type="checkbox"/> Yes <input type="checkbox"/> No		
		IF YES EXPLAIN with permission		
DESCRIPTION	7 STYLE OF BUILDING Greek Revival		DATE OF CONSTRUCTION ca. 1860	
	8 MATERIAL(S) (Indicate use or location when appropriate)			
	<input checked="" type="checkbox"/> Clapboard <input type="checkbox"/> Asbestos Siding <input type="checkbox"/> Brick <input type="checkbox"/> Other (Specify) _____

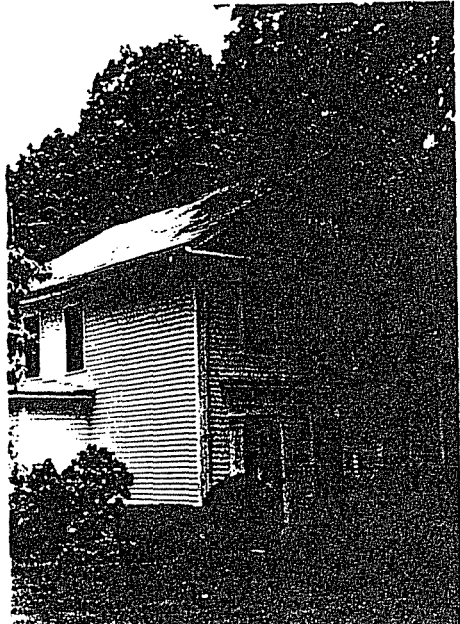
PHOTOGRAPHER	DATE
P. D. Hall	7/83
VIEW	NEGATIVE ON FILE
SW	1:20
NAME	DATE
P. D. Hall	5/84
ORGANIZATION	
Greater Middletown Preservation Trust	
ADDRESS	
27 Washington Street, Middletown, CT 06457

The Bristol house is a three-bay, side-hall plan, Greek-Revival-style residence. Its main entry is offset to the west side of the facade. It consists of flat antae pilasters with bases and caps surmounted by a flat full entablature. The facade is surmounted by a full pediment and framed with narrow corner pilasters. The gable peak contains an arch top, fixed two-over-two window. The fenestration is six-over-six throughout the structure. Two narrow hip-roofed additions have been made to the west and north sides of the house. As a late Greek-Revival-style structure, this house was built to be heated with stoves and never contained a fireplace. In the garden of this residence is a carved sandstone well parapet which stood originally in the yard of the John Johnson House.
