**HISTORIC RESOURCES INVENTORY**  
**BUILDING AND STRUCTURES**

IDENTIFICATION	1. BUILDING NAME (Common) _____ (Historic) Curtiss, James, House	
	2. TOWN CITY Durham	COUNTY Middlesex
	3. STREET AND NUMBER (and or location) Maiden Lane, south side, .3 m east of Main Street

JAMES CURTISS HOUSE, Durham

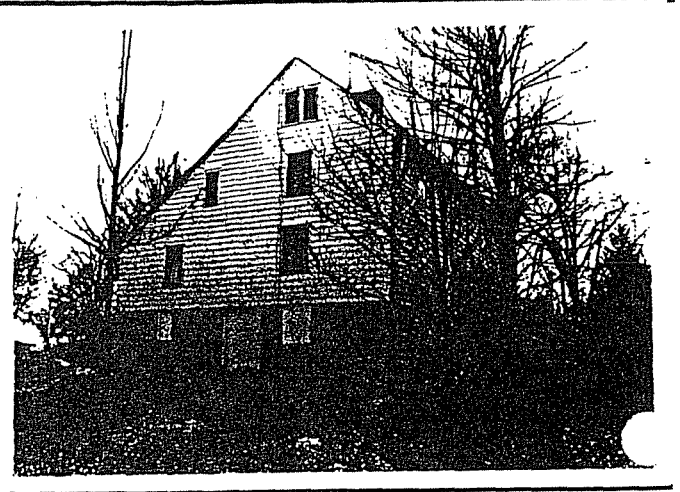
The James Curtiss House is a three-bay, central-chimney, colonial structure. It stands on a cut sandstone foundation which is exposed on its east side, revealing a shop door dating from the eighteenth century. The main entry is original and contains a two-leafed six-panelled doorway. The only remaining original fenestration is on the second story of the facade, which contains eight-over-twelve sash. A shed-roofed addition dating from the nineteenth century has been constructed on the southwest corner of the house.

<b>PHOTO</b>	<b>PHOTOGRAPHER</b> P. D. Hall	<b>DATE</b> 7/5/83
	<b>VIEW</b> North & east elev	<b>NEGATIVE ON FILE</b> 1:17
<b>COMPILED BY</b>	<b>NAME</b> P. D. Hall	<b>DATE</b> 5/15/84
	<b>ORGANIZATION</b> Greater Middletown Preservation Trust	
	<b>ADDRESS</b> 27 Washington Street, Middletown, CT 06457
