**HISTORIC RESOURCES INVENTORY
BUILDING AND STRUCTURES**

| | Chauncey, Charles, House | |
| | Cherry Lane (& Fowler Ave), East side | |

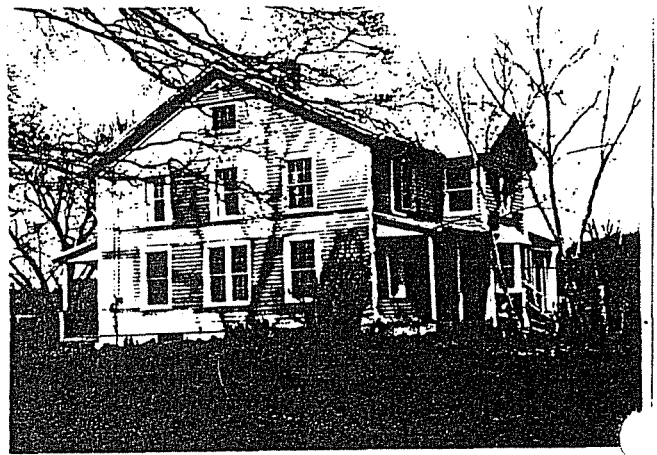
PHOTO

OTHER NOTABLE FEATURES OF BUILDING OR SITE (Interior and/or exterior)
 This house has undergone many changes. In 1720 Rev. Nathaniel Chauncey built a 1½ story, center-chimney gable-roofed house. The house burned and a new house was built by Charles Chauncey, grandson of Rev. Nathaniel, ca. 1780s. It is possible that a second story was added at this time with the entrance being on the north side. The house since then has undergone other alterations. Around the mid-nineteenth century full-length, 2 story north and south side balloon-framed extensions were added along with a large gable roof. The large chimney probably was replaced. At one point, a full-length, one-story, north addition was made with an open west porch entrance; on the south side a 2 story, balloon-framed, gable-roofed extension was added with a south-end half-length open porch, supported by two free-standing columns. The facade presently has three bays. Six-over-six sash flank a boarded-up double window where a possible center door might have been. The second (cont)

The Charles Chauncey house is a clapboarded, 2½ story, nineteenth-century domestic style building. The post-and-beam frame is oriented gable-to-street and is topped by a small center chimney, and rests on a sandstone-fieldstone foundation.

floor contains three windows and a six-paned window is centered in the gable. Other additions include a full length single story east side addition with a basement underneath.
