HISTORIC RESOURCES INVENTORY
BUILDING AND STRUCTURES
 HIST-6 NEW 5 77

IDENTIFICATION	1. BUILDING NAME (Common) _____ (Historic) <u>Merwin, Daniel, House</u>	
	2 TOWN CITY <u>Durham</u>	VILLAGE _____
	3 STREET AND NUMBER (and or location) <u>131 Main Street (a.k.a. 133 Main Street)</u>	
	4 OWNER(S) <u>McLaughlin, James W. and Ona H.</u> <input type="checkbox"/> Public <input checked="" type="checkbox"/> Private	
	5 USE (Present) _____ (Historic) <u>Residence</u>	
	6 ACCESSIBILITY TO PUBLIC: <input checked="" type="checkbox"/> Yes <input type="checkbox"/> No	EXTERIOR VISIBLE FROM PUBLIC ROAD <input checked="" type="checkbox"/> Yes <input type="checkbox"/> No
	7 STYLE OF BUILDING <u>Colonial</u>	
	DATE OF CONSTRUCTION <u>c. 1740</u>

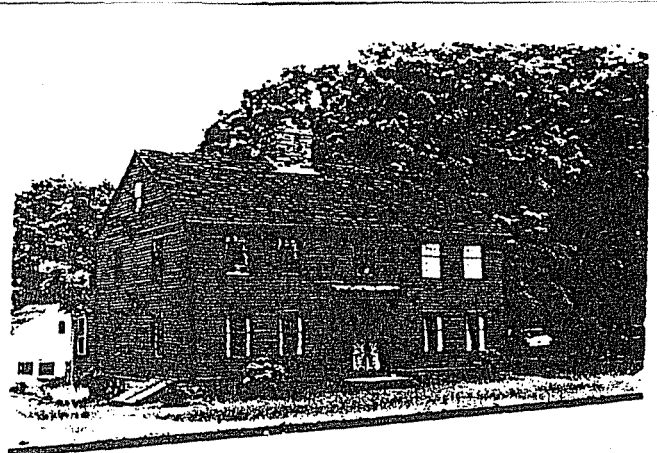
PHOTOGRAPHER Peter Hall	DATE 6/83
VIEW W	NEGATIVE ON FILE 3:30

This house stands on the west side of Main Street, close to the road. A two-story, gable-roofed garage is located southwest of the house. This structure has vertical flushboarding and arched windows in the gable ends. This property is located within Durham's local historic district.

From 1969 to 1979 the Daniel Merwin House underwent renovation. Although some of the clapboards are original, both the wood-shingling and the irregularly-coursed sandstone central chimney are replacements. The eight-over-twelve sash and the beaded trim boards are also restorations. The plainly trimmed doorway is surmounted by a shed-roofed door-hood. The double-leaf door itself has a latch handle and beaded flush panels. A full-length shed-roofed addition has been made to the rear. It has six-over-six sash and a sandstone block foundation.
