STATE OF CONNECTICUT  
CONNECTICUT HISTORICAL COMMISSION  
59 SOUTH PROSPECT STREET, HARTFORD, CONNECTICUT 06106  
(203) 566-3005

IDENTIFICATION	1. BUILDING NAME (Common) <i>Elias Austin</i>		(Historic) <i>Austin, Elias</i>	
	2. TOWN CITY <i>Durham</i>		VILLAGE	COUNTY <i>Middlesex</i>

3. STREET AND NUMBER (and or location) <i>111 Main St.</i>			
	4. OWNER(S) <i>Masfield, Elizabeth A.</i> <input type="checkbox"/> Public <input checked="" type="checkbox"/> Private

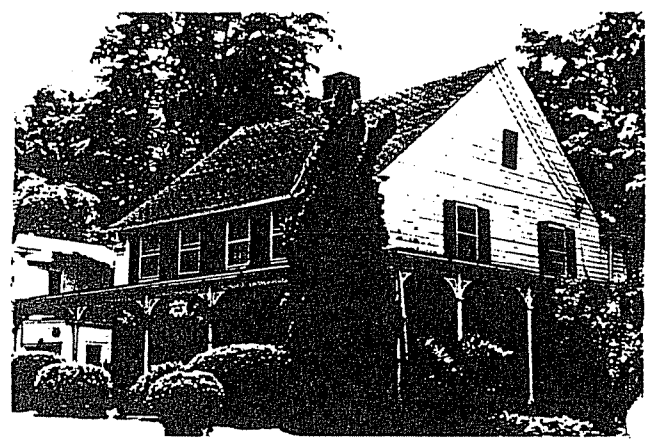
PHOTOGRAPHER		DATE	
Peter Hall		6/83	
VIEW	NEGATIVE ON FILE		
NE	6:30		
NAME		DATE	
J. McCord		8/83	
ORGANIZATION			
Greater Middletown Preservation Trust			
ADDRESS			
27 Washington St., Middletown, Conn. 06457

The hip-roofed facade porch wraps around three sides of the house and is supported by slender, chamfered pillars with cut-and-sunk brackets. These give the impression of continuous flat ellipses between the posts. The central doorway is marked by entry pilasters with long, round medallions, and is flanked by four 6/6 sash windows. The second-story windows are 8/12 sash. All full-size windows of the house have louvred shutters. Greek Revival style, fluted, corner pilasters, with entasis, are present. Various additions have been made to the rear and to the north side.

The Elias Austin House, built ca. 1745, is a 5-bay, gable-ridge-to-street Colonial period structure with some Greek Revival style touches. The 2½-story, central chimney, wooden, post-and-beam frame has an asphalt-shingled roof, a clap-board exterior, and a sandstone foundation. In 1743, Elias Austin bought this lot from Robert Fairchild for '153 pounds current money' (DLR 5:446). When Austin's will was executed in 1776, his home lot passed to his wife and sons. Among the latter was Moses Austin, who left Durham at the end of the eighteenth century. An early western pioneer, he eventually reached Texas in the 1820s, where he received a large land grant from the Mexican Government. He died soon afterwards, but his son, Stephen F. Austin, laid claim to his father's land and, in 1822, laid out the town of Austin, the present-day capitol city of the state of Texas. The Elias Austin House passed out of the family in 1783, and has since changed hands many times. This house served as Durham's post office from 1909 to 1935. This building is important as the original home and birthplace of Durham's perhaps most noted emigrant, Moses Austin.
