**HISTORIC RESOURCES INVENTORY
BUILDING AND STRUCTURES**

| IDENTIFICATION | 1. BUILDING NAME (Common) --- (Historic) Butler, Jeremiah, House | |
| | 3. STREET AND NUMBER (and or location) 107 Main Street | |

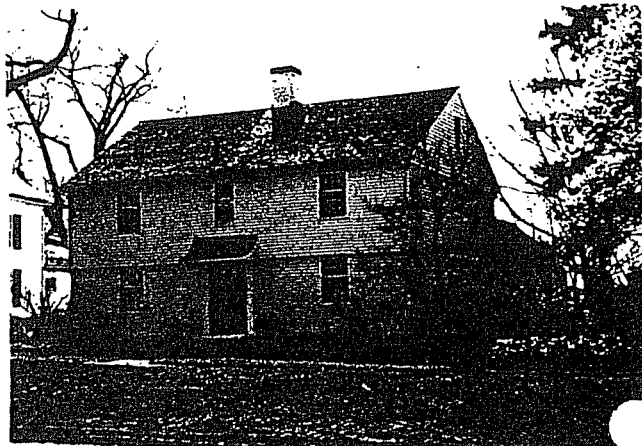
| W | 11:32A |

The plain, trim facade central doorway is surmounted by a convex doorhood. The double leaf, moulded panel doors each have replacement toplights. Full windows are 8/12 sash. A shed-roofed addition is attached to the northwest corner.

The Jeremiah Butler House is a three-bay, 2 1/2 story Colonial period double-overhang building, erected c. 1775. Its wooden post-and-beam frame has a wood-shingled gable roof with a replacement painted brick central chimney, clapboarding, and a cut sandstone foundation. In 1772, Isaac Jones of Milford sold this lot to Jeremiah Butler. When Butler finally conveyed the property to Guernsey Bates forty years later, it had a dwelling house upon it. The house was owned by the Parsons family from 1839 until this century. Jeremiah Butler was one of Durham's leading citizens and a prosperous shoemaker. As a lieutenant, he was chosen in 1782 to be a member of a committee "...to procure able bodied men to serve in a Regiment ordered by the General Assembly ...to be raised for the defense of Horse Neck and the western frontier." (Fowler, 1866, pp. 143-144). In 1805 he served as a Durham representative in the state General Assembly. His prosperity did not last, however, for like many of the town's shoemakers, he was caught up in the turbulence of the early national economy. In 1831 judgements were delivered against him for unpaid debts, and a warrant for his arrest was issued. The Jeremiah Butler House is an example of classic Colonial period architecture.
