STATE OF CONNECTICUT
CONNECTICUT HISTORICAL COMMISSION
59 SOUTH PROSPECT STREET, HARTFORD, CONNECTICUT 06106
(203) 566-3005

IDENTIFICATION	1. BUILDING NAME (Common) (Historic)		Tucker, Henry, House/Congregational Parsonage		
	2. TOWN CITY		VILLAGE	COUNTY	
	Durham			Middlesex	
	3. STREET AND NUMBER (and or location)				
	105 Main Street

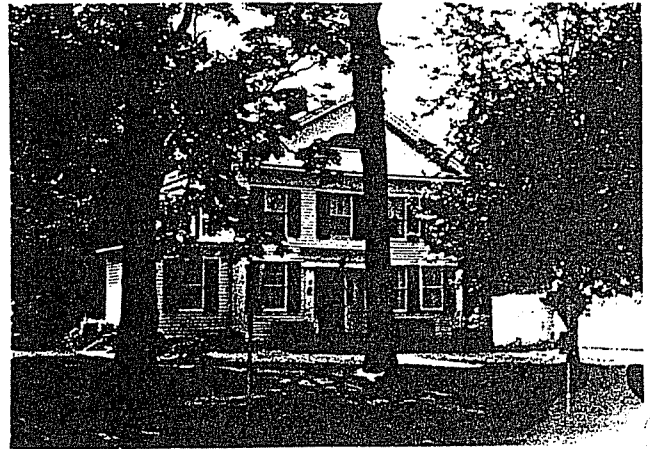
PHOTO

In the full pediment of the facade gable is a flattened elliptical fanlight with leaden tracery. A plain frieze runs around the eaves of the house. The corner pilasters, marked by a slight entasis, rise to capitals. The recessed central doorway is flanked by pilasters and is surmounted by a full entablature with a dentil course. The six-panelled original door has a five-pane leaded sidelight on each side. The full 6/6 sash windows have louvred shutters. A long shed-roofed addition is attached to the northwest corner. A small hip-roofed porch has been added to the southeast corner.

The Tucker House, built in 1838, is a 2 1/2 story, four bay, gable-to-street Greek Revival style building. It has a central-hall plan, a central chimney, clapboarding, and a coursed sandstone foundation.

PHOTOGRAPHER	DATE
Peter Hall	6/83
VIEW	NEGATIVE ON FILE
East side	6:27
NAME	DATE
Jonathan McCord	8/83
ORGANIZATION	
Greater Middletown Preservation Trust	
ADDRESS	
27 Washington Street, Middletown, CT 06457
