**HISTORIC RESOURCES INVENTORY
BUILDING AND STRUCTURES**
HIST-6 NEW 5-77

1. BUILDING NAME (Common)		(Historic)	
-----		Leach, Leverett W., House	
2. TOWN CITY	VILLAGE	COUNTY	
Durham		Middlesex	
3. STREET AND NUMBER (and or location)			
101 Main Street			
4. OWNER(S)			
Atwell, Frederick L., c/o Atwell, George			<input type="checkbox"/> Public <input checked="" type="checkbox"/> Private
5. USE (Present)		(Historic)	
Residence		Residence	
6. ACCESSIBILITY TO PUBLIC:	EXTERIOR VISIBLE FROM PUBLIC ROAD	INTERIOR ACCESSIBLE	IF YES, EXPLAIN
<input checked="" type="checkbox"/> Yes <input type="checkbox"/> No	<input type="checkbox"/> Yes <input checked="" type="checkbox"/> No

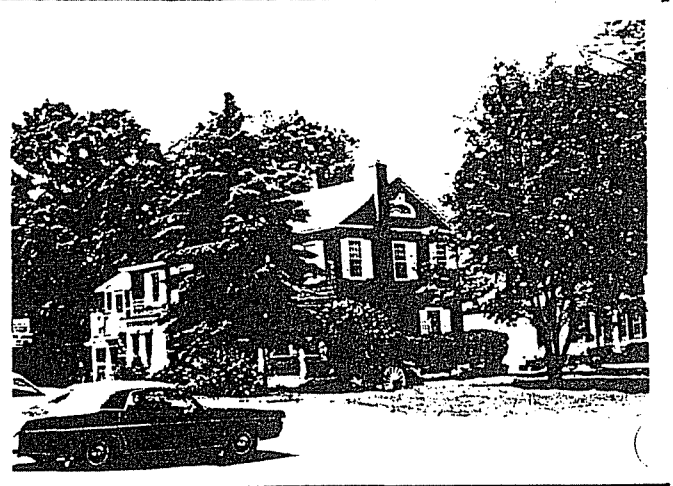
PHOTO	PHOTOGRAPHER	DATE
	Hall, Peter	6/83
COMPILED BY	VIEW	NEGATIVE ON FILE
	Southeast	6:26
	NAME	DATE
	McCord, J.	8/83
ORGANIZATION		
Greater Middletown Preservation Trust		
ADDRESS		
27 Washington Street, Middletown, Conn. 06457

The entry on the 5-bay south side is an unusual feature of this house. The central doorway has plain capped pilasters which rise to a full plain entablature. A partially enclosed porch has square, chamfered posts on pedestals, with sawn and cutout brackets and quatrefoils. These lead to a single-story projecting pavilion. The gable has a full pediment and a Federal fanlight window. The full 12/12 sash windows are shuttered. A flat-roofed addition and a shed-roofed screen porch, both two stories high, have been attached to the south side, with another screen porch on the north side.

The Leverett W. Leach House, built c. 1840, is a 3-bay, 2 1/2 story, gable-to-street, Federal style building with an asphalt-shingled roof, asbestos shingle siding, and a mortared, sandstone block foundation. Dennis Camp conveyed this lot to Leverett W. Leach, a Durham merchant, in 1839. A store was on the tract at that time, but was soon torn down or otherwise removed. The 1859 Durham Business Directory shows both the new Leach House and his new store, erected between the house and the Congregational Church. In 1893, the house passed into the Atwell family, whose property it remains to this day. This house was the home of one of Durham's most important nineteenth-century merchant families. It was appropriately built next to the family store.
