**HISTORIC RESOURCES INVENTORY  
BUILDING AND STRUCTURES**

1. BUILDING NAME (Common) (Historic)	
First Church of Christ North Congregational Church	
2. TOWN CITY	COUNTY
Durham	Middlesex
3. STREET AND NUMBER (and or location)	
Main Street

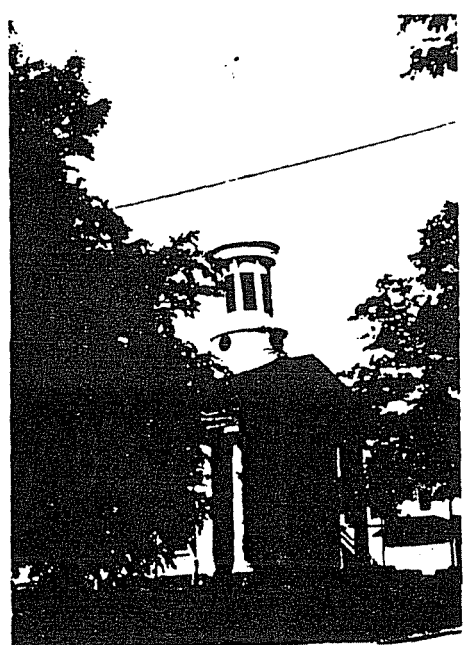
Antapilasters are at each corner of the facade, behind the colonnade. The double-length central doorway is surmounted by a flat cornice, which in turn is supported by two scrolled consoles. Above and within is a large wooden rosette. The double-leaf doors each have a recessed triple panel within, and a transom above. The full-length steps are wooden. The early Colonial Revival style spire is round with four face clocks. Corinthian columns surround the louvred belfry and rise to a round entablature with a dentil course. The rest of the spire has fish-scale shingling to the top. The north and south sides of the building have three-quarter length 24/24 sash windows. A gable-roofed addition has been made to the southwest corner of the main building. [CONT'D in 19]

19 HISTORICAL OR ARCHITECTURAL IMPORTANCE  
 [17, CONT'D] The addition's portico is supported by four square, fluted posts connected by a curved spandrel. A vertical-flushboarded skirt covers its coursed sandstone block foundation.  
 [19] The First Church of Christ in Durham is a 2 1/2 story, gable-to-street Greek Revival style structure built in the mid-nineteenth century. Its wooden, post-and-beam frame has an asphalt-shingled roof, a clapboard exterior, and a coursed sandstone foundation. This building was the fourth meeting house of the Congregational Church to be erected in Durham. The third meeting house, which stood on the site of the present Town Hall, burned in 1844. The schism between the north and south congregations of Durham occurred soon afterwards. The North Congregational Church was dedicated in 1847 and the South Congregational Church (the present Town Hall building) in 1849. Denis Camp granted the lot for the North Church in 1847 to the First Ecclesiastical Society of Durham "...for the purpose of building a Church thereon..." (DLR 19:310). When the United Churches Corporation was formed, the North Church was given its present name, the First Church of Christ. The First Church of Christ is significant as one of Durham's ecclesiastical structures. It owes its origins to a nineteenth century religious schism in the community.

PHOTO	PHOTOGRAPHER Hall, Peter	DATE 6/83
	VIEW Southeast	NEGATIVE ON FILE 6:24
COMPILED BY	NAME McCord, J.	DATE 8/83
	ORGANIZATION Greater Middletown Preservation Trust	
	ADDRESS 27 Washington Street, Middletown, Conn. 06457	
20 SUBSEQUENT FIELD EVALUATIONS
