HISTORIC RESOURCES INVENTORY
BUILDING AND STRUCTURES
 HIST-6 NEW 5 77

IDENTIFICATION	1. BUILDING NAME (Common) (Historic)		Strong, Asahel, House		
	2. TOWN CITY	VILLAGE	COUNTY		
	Durham		Middlesex		
	3. STREET AND NUMBER (and or location)				
	83 Main Street

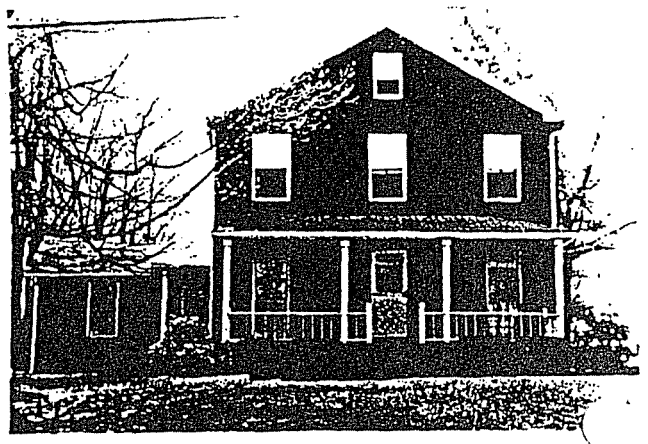
VIEW: W NEGATIVE ON FILE: 11:27A

A flat, crown-moulded cornice with a dentil course is located above the panelled, central facade door. Two 6/3 sash vertical windows flank this doorway. The full-length, hip-roofed, facade porch is supported by simple stick columns which rise from a stick balustrade to square, moulded capitals. The full windows of the second story are 2/2 sash. A small 3.3 is in the gable, which in turn has slight cornice returns. A single story lean-to has been added to the west side of the house. A gabled pavilion is attached to the southwest corner.

The Asahel Strong House, built ca. 1830, is a 2 story, 3 bay, nineteenth-century domestic vernacular building. Its wooden, post-and-beam frame rests on a mortared sandstone foundation and has an asbestos-covered gable-to-street roof, a central chimney and central hall, and an asbestos-sided exterior.
