**HISTORIC RESOURCES INVENTORY  
BUILDING AND STRUCTURES**

IDENTIFICATION	1. BUILDING NAME (Common) <span style="float: right;">(Historic)</span> Meigs, Elias, House
	2. TOWN/CITY <span style="float: right;">VILLAGE</span> <span style="float: right;">COUNTY</span> Durham <span style="float: right;">Middlesex</span>
	3. STREET AND NUMBER (and or location) Town House Road, west side, 1 m. south of Maple Avenue
	4. OWNER(S) Hugh and Judith Cox <span style="float: right;"><input type="checkbox"/> Public <input type="checkbox"/> Private</span>
	5. USE (Present) <span style="float: right;">(Historic)</span> Residence <span style="float: right;">Residence</span>

7. STYLE OF BUILDING Federal	DATE OF CONSTRUCTION 1831
---------------------------------	------------------------------

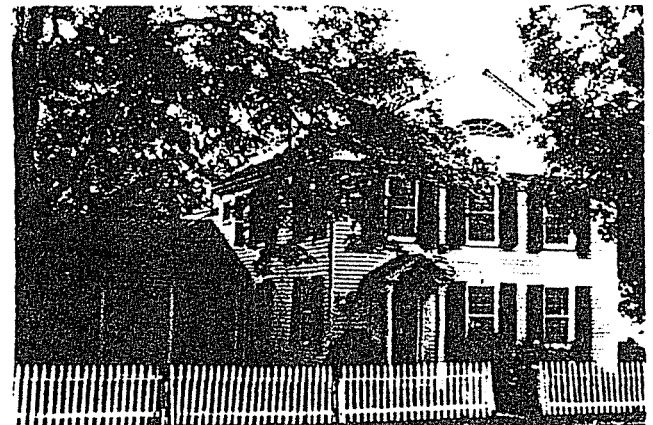
This 2½ story Federal-style residence in many ways resembles the Charles Camp House, which stands just to the south of it. Both are side-hall plan structures with gable ends facing the street. The Meigs House, however, possesses that hallmark of the Federal style, a demi-lunette fanlight in its gable peak. It also possesses an elegant leaded glass fanlight over its front entry, which is protected by a cove-ceilinged gable-roofed portico supported by Doric columns. A shed-roofed 10 x 16 addition, probably contemporary with the main block, stands to the rear of the structure. In 1980 a single-story gable-roofed addition was made to the south side of the main block.

PHOTO	PHOTOGRAPHER P. D. Hall	DATE 7/5/83
	VIEW East elevation	NEGATIVE ON FILE 6:1
COMPILED BY	NAME P. D. Hall	DATE 5/15/84
	ORGANIZATION Greater Middletown Preservation Trust	
	ADDRESS 27 Washington Street, Middletown, CT 06457
