STATE OF CONNECTICUT
 CONNECTICUT HISTORICAL COMMISSION
 59 SOUTH PROSPECT STREET, HARTFORD, CONNECTICUT 06106
 (203) 566-3005

IDENTIFICATION	1. BUILDING NAME (Common) (Historic)	
	Cardinal Antiques Markham, Dr. Ernest A., House	
	2. TOWN CITY	VILLAGE
	Durham	Middlesex
	3. STREET AND NUMBER (and or location)	
	77 Main Street

STATE OF CONNECTICUT
CONNECTICUT HISTORICAL COMMISSION
59 South Prospect Street, Hartford, Connecticut 06106
HISTORIC RESOURCES INVENTORY FORM
For Buildings and Structures

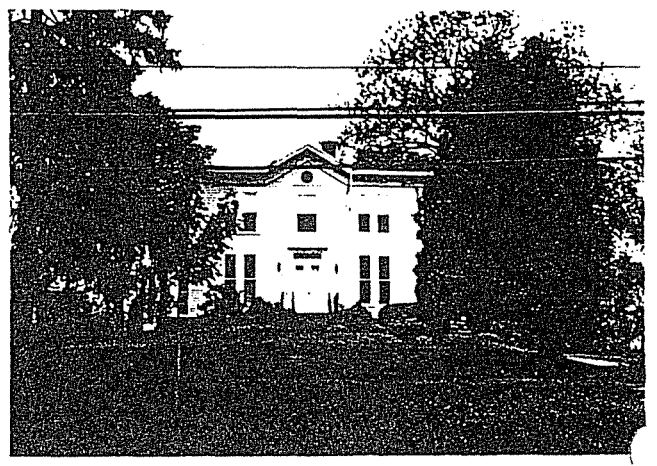
VIEW from West	NEGATIVE ON FILE 6:17
-------------------	--------------------------

Doorway is flanked by two pairs of tall, vertical windows with 1/1 sash. In the center of the facade is a low, gabled domer with an oculus bordered by simple, sawn wooden ornament.

The Dr. Ernest A. Markham House, built ca. 1885, is a 2 story Victorian domestic building with a central hall plan, a central chimney, an asphalt-covered low hip roof, clapboarding, and a coursed sandstone foundation. The 3 bay facade has a central double doorway with plain trim. The doorway is surmounted by a 5 paned transom and a crown-moulded cornice, and is flanked by two pairs of tall, vertical windows with 1/1 sash. At roof level in the center of the facade is a low, gabled domer with an oculus bordered by simple, sawn wooden ornament. The influence of the Greek Revival style is betrayed by the entablature around (see continuation

the house and the suggestion of corner pilasters. A hip-roofed porch has been added to the north side. Multiple additions have been made to the west side, and on the south side is a 5 sided, 2 story, Queen Anne style bay resting on a coursed sandstone foundation.
