STATE OF CONNECTICUT
 CONNECTICUT HISTORICAL COMMISSION
 59 SOUTH PROSPECT STREET, HARTFORD, CONNECTICUT 06106
 (203) 566-3005

| IDENTIFICATION | 1. BUILDING NAME (Common) <i>(Historic)</i> | | The Walker House | | Hubbard, Reuben Homestead House | |
| | 70 Main Street | | | | | |

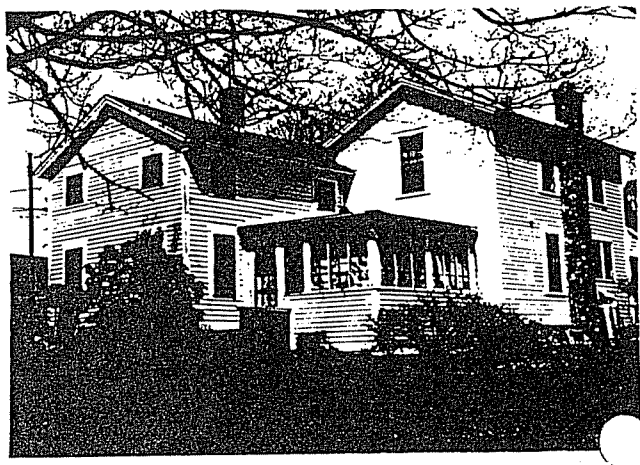
| VIEW S&W elevations | NEGATIVE ON FILE 11:24A |

This house, as built, consisted of two simple gable roofed structures joined at their southeast and northwest corners. Both sections were narrow, the largest 16' wide, the smaller rear section, 14' in width. The gable ends of both face the street. At some point after the turn of the century, a one story hip-roofed sun/entry porch was added to the south and west sides of the house and the main entry was moved forward some 12 feet. While the fenestration consists of 6X6s, save for the 3X3 eyebrow windows in the northwest section, there is evidence that the window arrangement has been changed, most notably on the south side of the southeast section, where an exterior brick chimney was added at some point in this century.
