**HISTORIC RESOURCES INVENTORY
BUILDING AND STRUCTURES**

1. BUILDING NAME (Common) (Historic)
Hale, Zebulon, House

3. STREET AND NUMBER (and or location)
50 Main Street (east side)

7. STYLE OF BUILDING: Greek Revival DATE OF CONSTRUCTION: ca. 1840

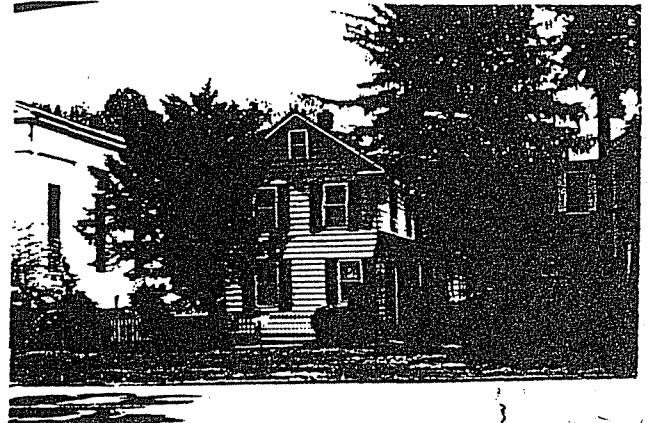
PHOTOGRAPHER	DATE
P. D. Hall	Summer 1983
VIEW	NEGATIVE ON FILE
west or front view	III:34
NAME	DATE
I. Heublein	8/2/83
ORGANIZATION	
Greater Middletown Preservation Trust	
ADDRESS	
27 Washington Street, Middletown, CT 06457

When constructed, the Hale House undoubtedly exhibited several Greek Revival features, including corner pilasters and possibly a pediment. Presently aluminum-sided, the only original decorative features still visible are the vestiges of the cornice returns or pediment on the facade. The entrance, rather than being located on the facade, is located in a single story full-length south-side addition with a shed roof.

Constructed in 1840, the Zebulon Hale House is a 2½ story, two bay Greek Revival style building. It rests on a sandstone foundation and is topped by a slate gable-to-street roof and central chimney. All full-sized windows are six-over-six sash flanked by louvred shutters.
